# Engineering Features of the Recent Mexican Earthquake

by James L. Beck and John F. Hall

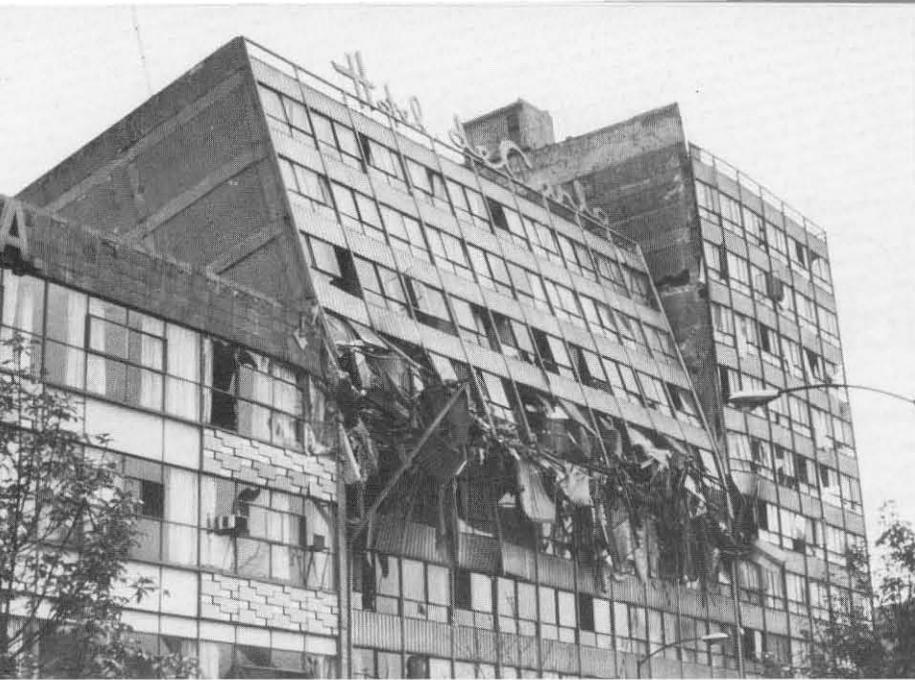
*The unique mid-level collapse of the hotel shown above may have resulted from a discontinuity in the structural system. This case presented quite a dilemma for the demolition crew, because the hotel is leaning over a row of undamaged apartment buildings in the rear. The leaning portion of the structure was finally removed piece by piece.*

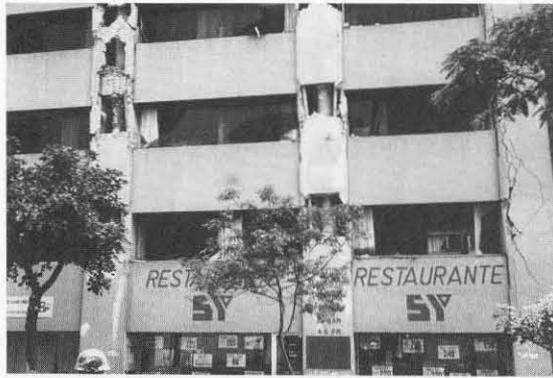
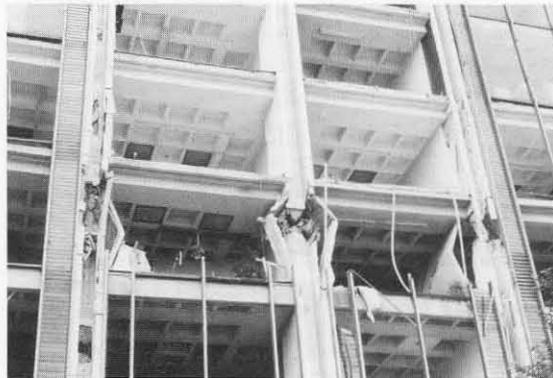
*Only one of the original three sections of the Nueva Leon apartment building, a twin to the building in the background, remains standing (right, foreground). The close-up (below) of the remaining section reveals weak columns, a number of which failed.*

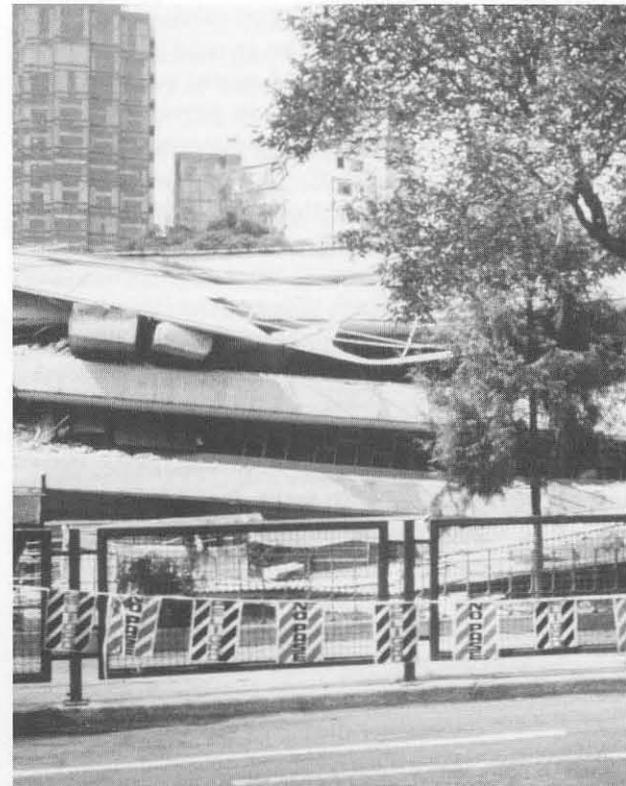
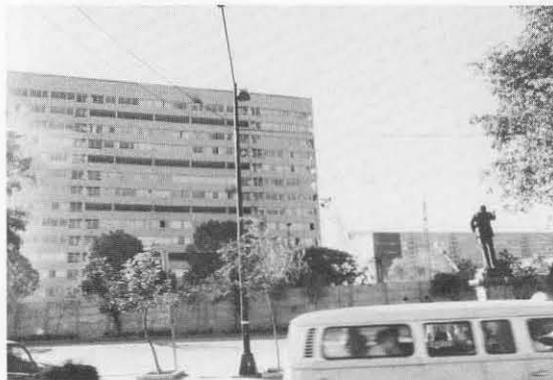
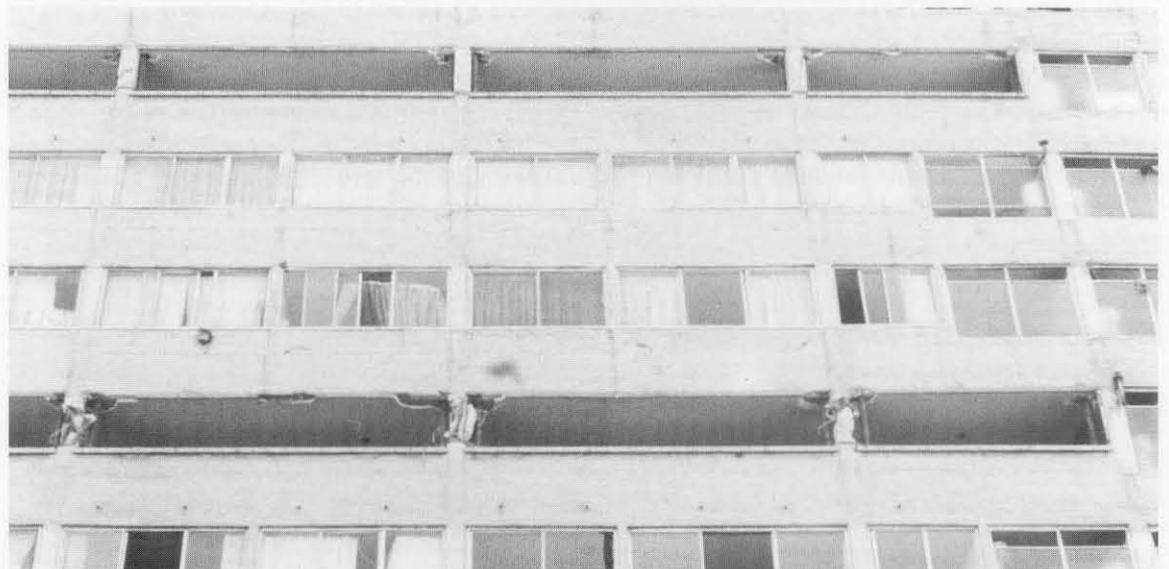
*In design, ductility is interrelated with strength because if the strength of a building is too low, then the ductility demanded by an earthquake is very high. In Mexico City, lack of strength was evident in the columns of many buildings. When such buildings survived, they did so by narrow margins.*

*Most of the buildings that suffered full or partial collapses probably lacked ductility, that is, the ability to undergo considerable yielding without losing strength. Since even the best built buildings yield during strong ground shaking, ductility is essential to avoid collapse, especially for long-duration earthquakes when a number of yield cycles occur. In reinforced concrete construction, proper detailing and placement of the steel reinforcing bars is an important element in providing ductility. Perhaps with longer bar anchorages and extra hoops to confine the concrete, the school shown above would have safely survived the long duration of the Mexican earthquake.*

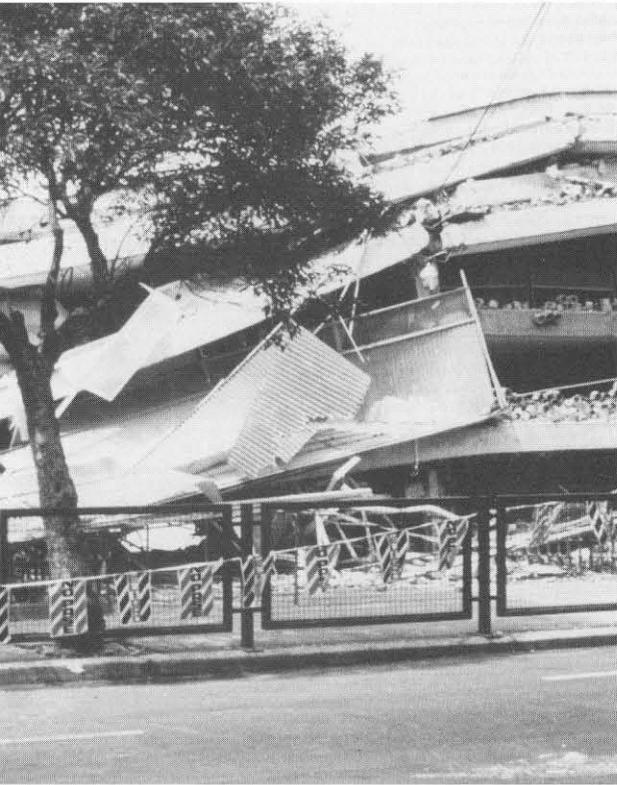
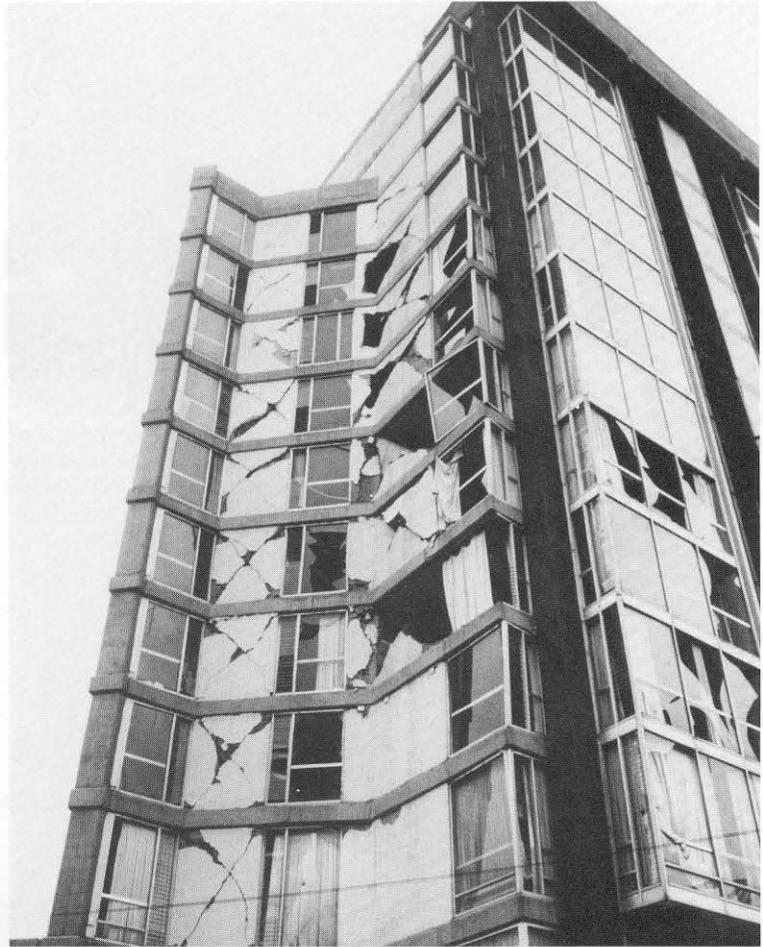
*The use of unreinforced masonry to fill in exterior walls between reinforced concrete frames is a common construction practice in Mexico City. The masonry panels, being stiff, attracted a large share of the earthquake load and, being brittle, often failed. So these types of buildings were particularly susceptible to the effects of period elongation described earlier. In addition, use of masonry infills on three sides of a building, while leaving the front open, created a nonsymmetric distribution of stiffness, causing a torsional response that increased the stress on the structural elements in the perimeter of the building. The building above shows diagonal cracks typical of shear overstress.*

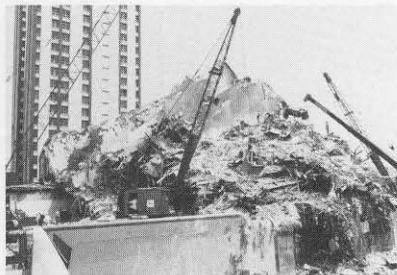
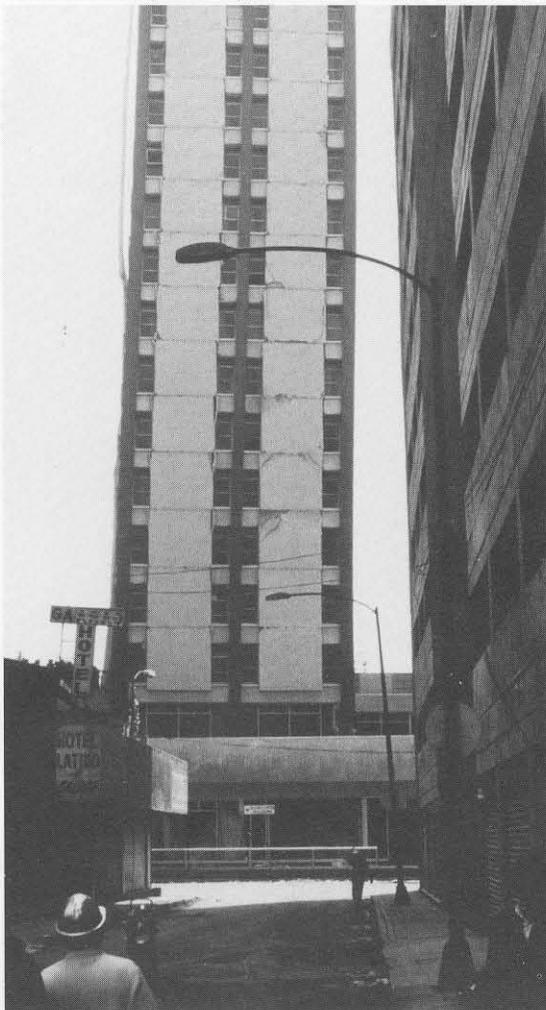
*Steel construction is rare in Mexico City, yet one of the most spectacular examples of damage occurred to the complex of five steel-frame buildings at Conjunto Pino Suarez. The 21-story tower shown at left, one of three buildings that remained standing, is leaning six feet out of plumb at the roof level due to yielding which produced permanent interstory drift. To the right of this tower stood a fourth one, also 21 stories, that toppled onto a fifth tower of 14 stories, bringing it down as well. The toppled tower, shown above, which employed truss beams and box columns, overturned at the third-floor level. Failure may have been initiated in the trusses from buckling of the chords or in the truss-to-column connection by fracture of the weld.*

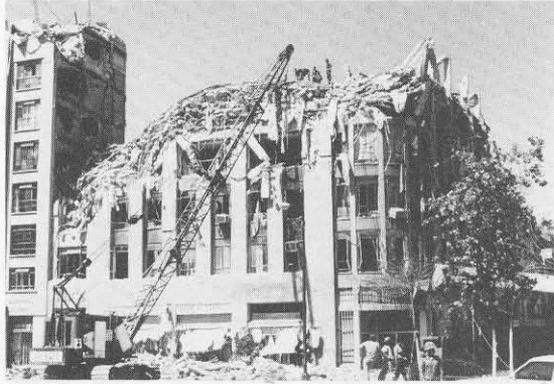
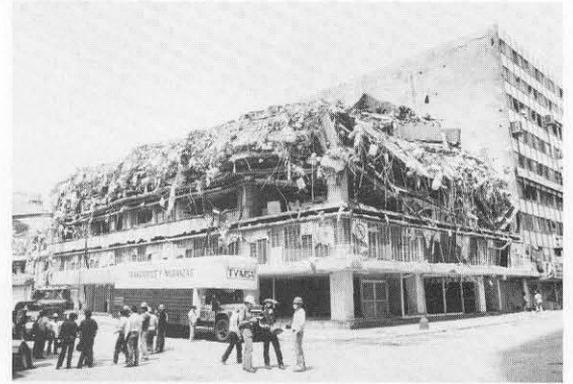
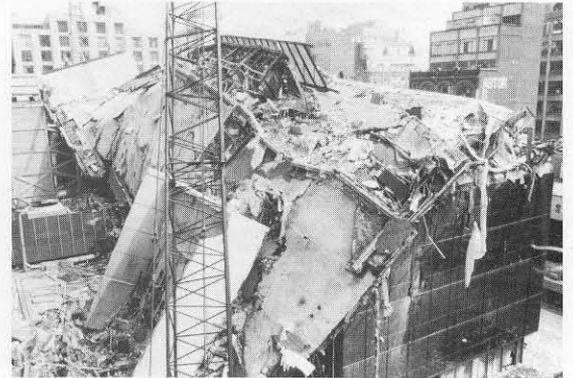
*An interesting characteristic of the damage in Mexico City is that a great number of buildings collapsed in their top stories, leaving the lower portion intact. Three examples are shown here. One possible reason for this behavior is that designers tapered the column sizes too severely in the upper stories, permissible if only gravity and wind loads act, but unwise for earthquake loads.*

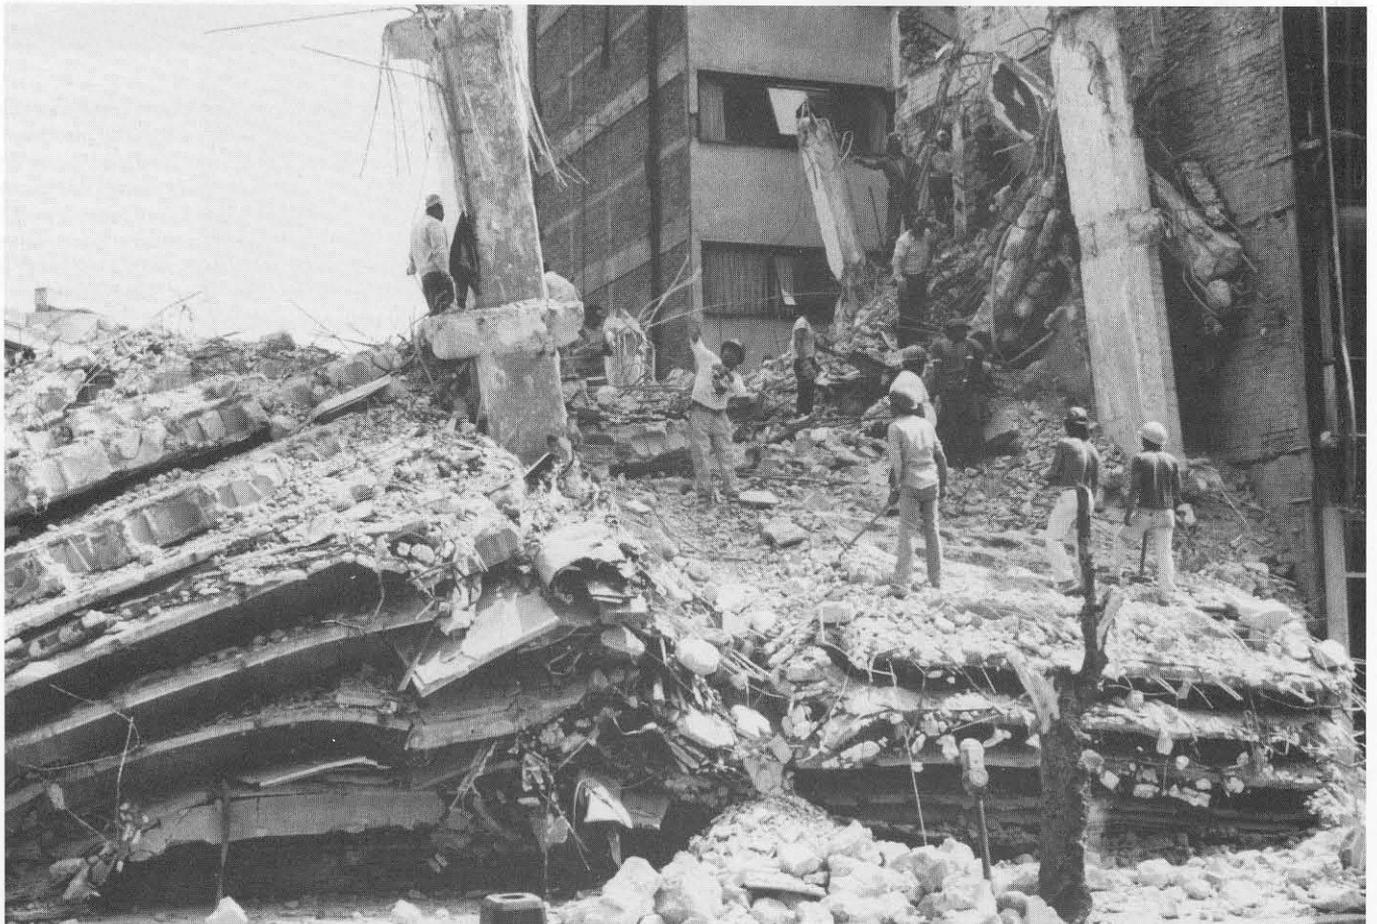
*Flat-plate construction, consisting of reinforced concrete slabs and columns without beams, did not fare well in the earthquake. Inadequate shear strength in the slab-to-column connection resulted in pancake failures of the slabs with the columns remaining upright in many cases.*

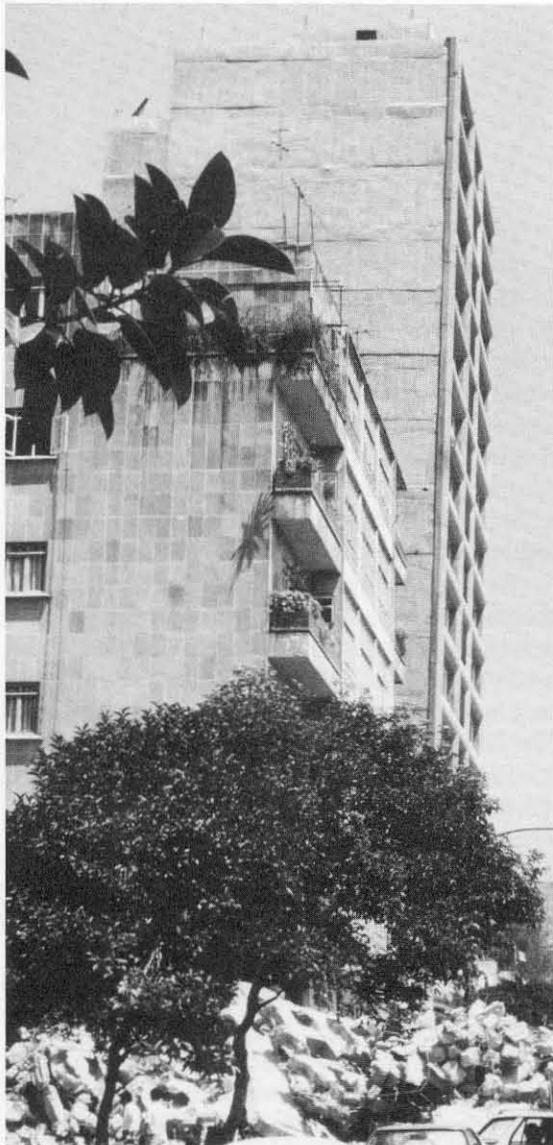
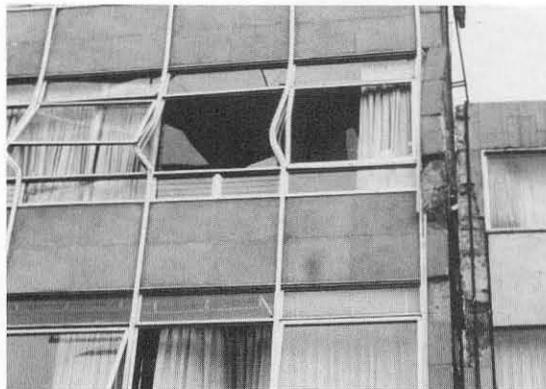
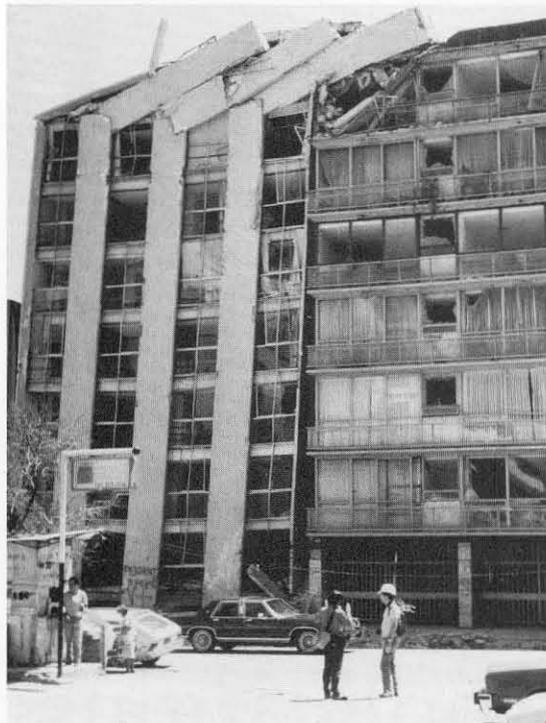
*During the earthquake, buildings swayed back and forth; a 15-story building may have swayed as much as two feet at the roof level in each direction. Closely spaced buildings thus have the opportunity to damage each other through impact. These photos show examples of impact damage; the lower one suggests another reason why the top portion of some buildings collapsed.*
