# SALVAGE OF THE OKLAHOMA

## at Pearl Harbor

By LEE P. MORRIS

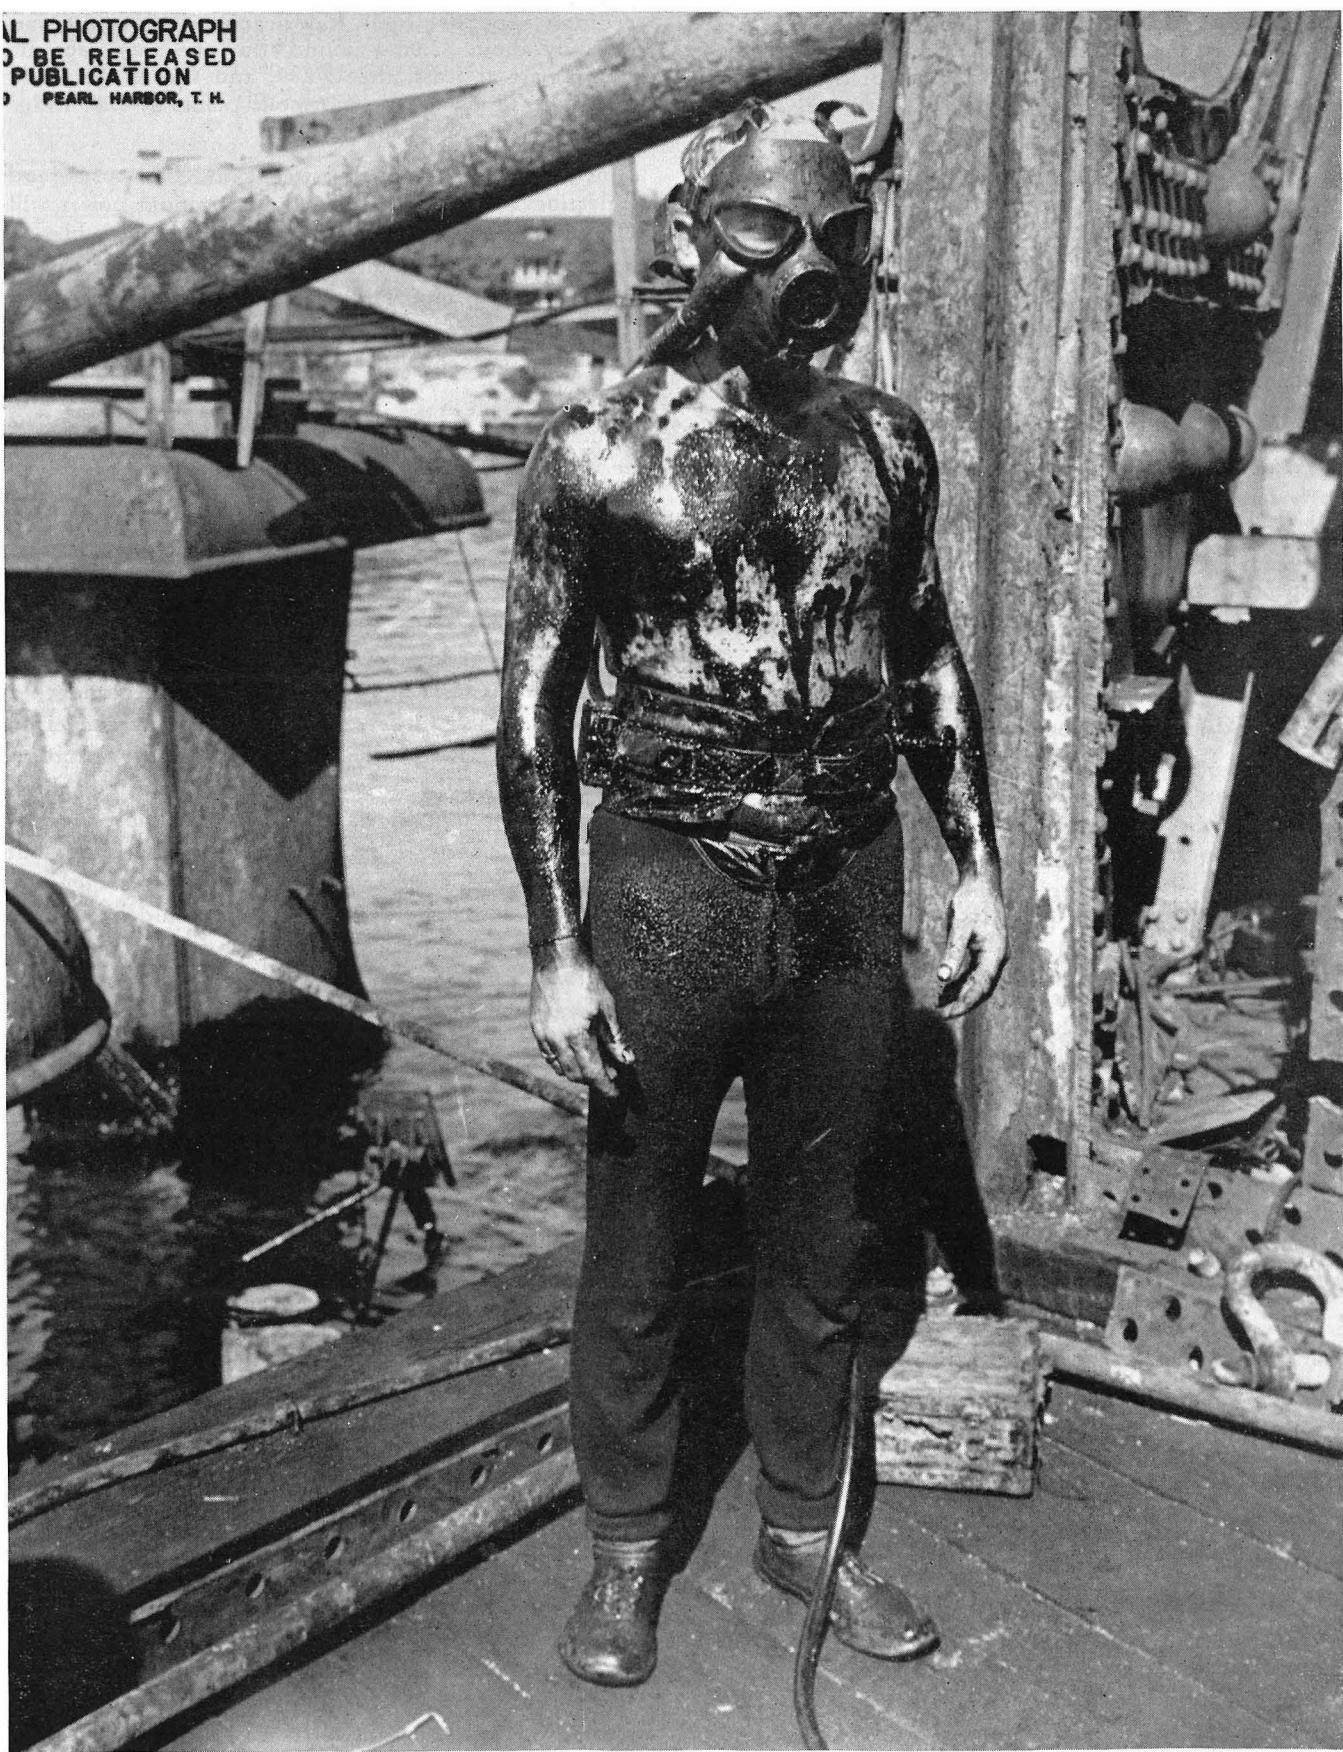
Fig. 1 A closeup of the diving dress worn for work in unwatered compartments, which were sometimes under air pressure, and in shallow water diving (less than 35 ft) where simple, relatively non-hazardous work was required.

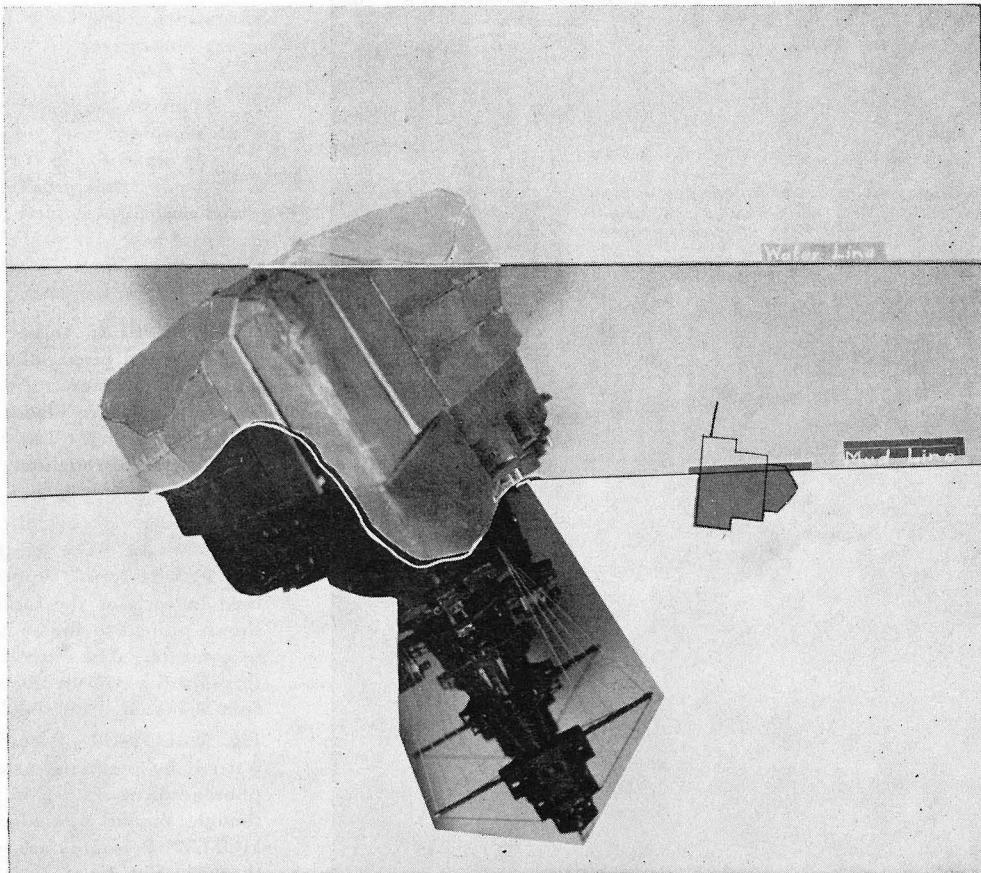
Fig. 2 Cardboard model of the OKLAHOMA placed to show the position of the ship before righting. The S-shaped mud line was caused by a mud bank formed when the forward section of the ship became embedded in soft mud before it capsized.

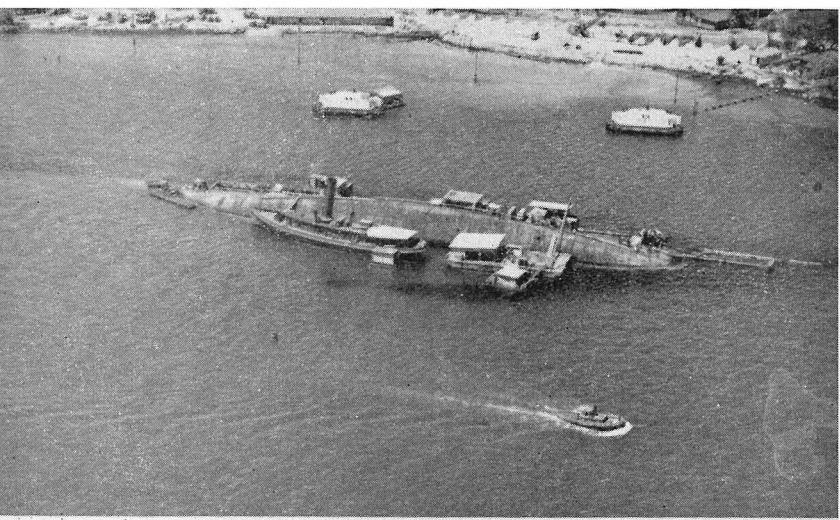
Fig. 3 UPPER: An aerial view, showing the various facilities used in initial preparations for salvage, including diver's floats and air compressors. Accessible fuel oil, the starboard propeller, and the three blades of the port propeller were removed prior to righting. The tug shown was used as a tender and headquarters throughout most of the operation.

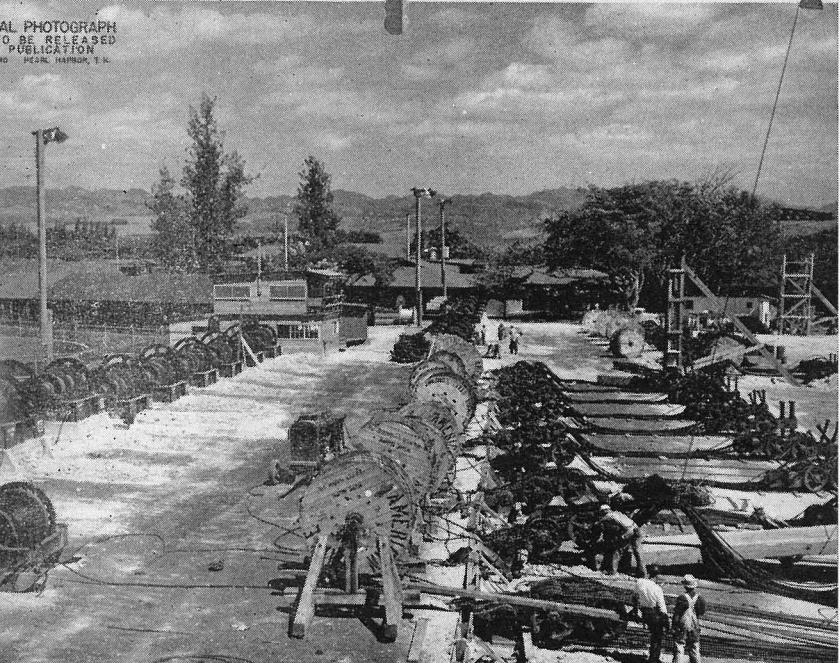
Fig. 4 CENTER: Winches and righting tackles, looking north showing central control station, and midship and after position stations. The block assemblies are reeved with 1 in. 6 x 19 wire rope. Approximately 9500 ft of 1 in. rope was used in each of the tackle assemblies. The inner blocks are shown pinned to the ends of steel beams which were anchored in concrete. The outer blocks are each to be attached to two three-in. 6 x 37 wire rope lines which will be extended to "A" frames mounted on the bottom of the ship.

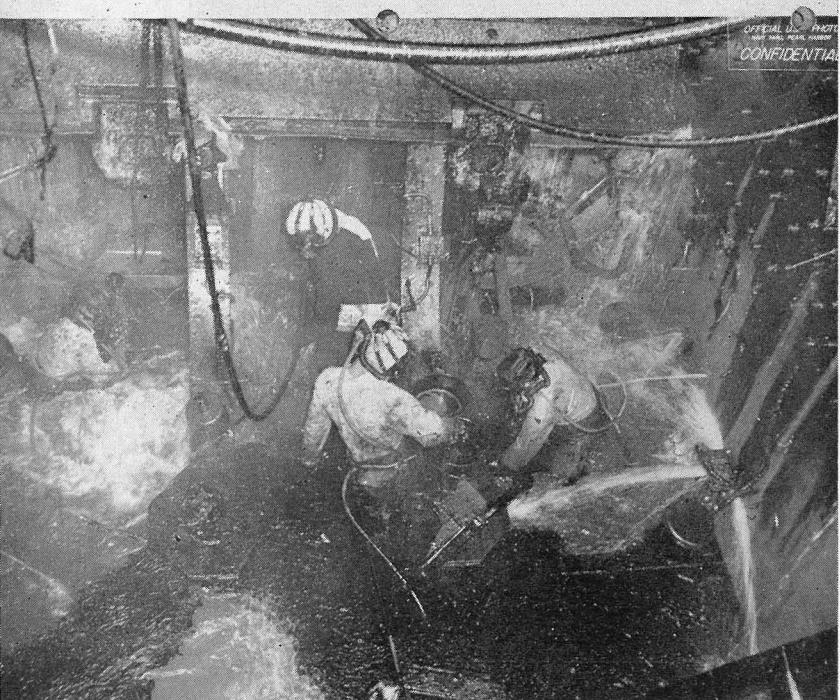
Fig. 5 LOWER: Recovering equipment from a turret, unwatered by pumping, after removal of guns and slides. This photograph was taken in the #2 turret of the *ARIZONA*, although similar operations were performed on the *OKLAHOMA*. Personnel are wearing the shallow-water diving dress shown in Fig. 1.

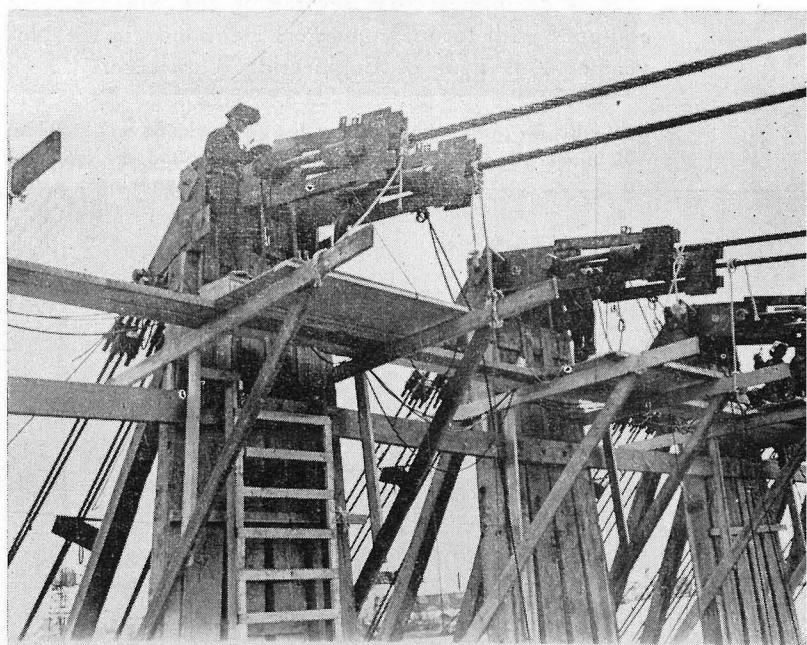
Fig. 6 LOWER LEFT: Outer or moving blocks composed of eight 28 in. diameter sheaves, eight 24 in. diameter sheaves, and one 20 in. diameter sheave. The small sheave served to equalize the tension on each pair of load lines extending from an individual winch. All tackle was especially designed for the job.

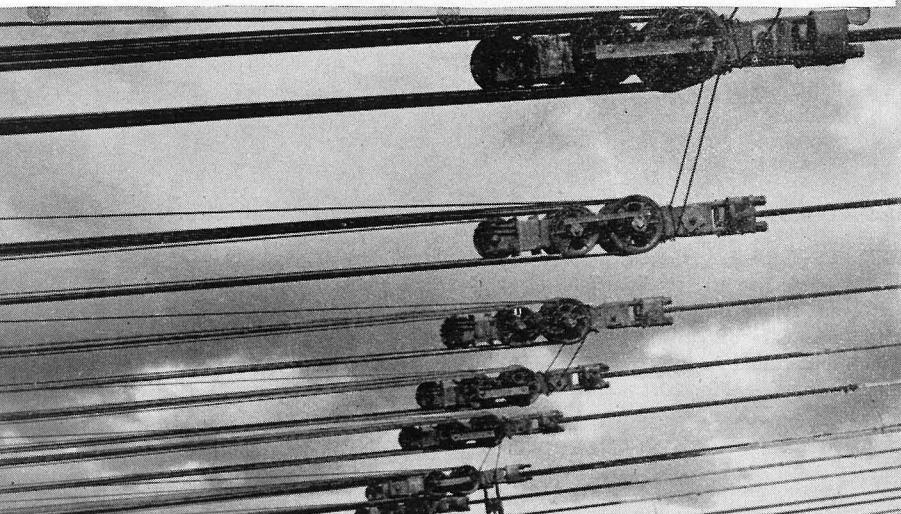
Fig. 7 UPPER RIGHT: "A" frame head fittings, fabricated from heavy steel plate. Of welded construction, these were bolted to steel plate extensions on the "A" frames and pinned to allow rotation in a lateral plane.

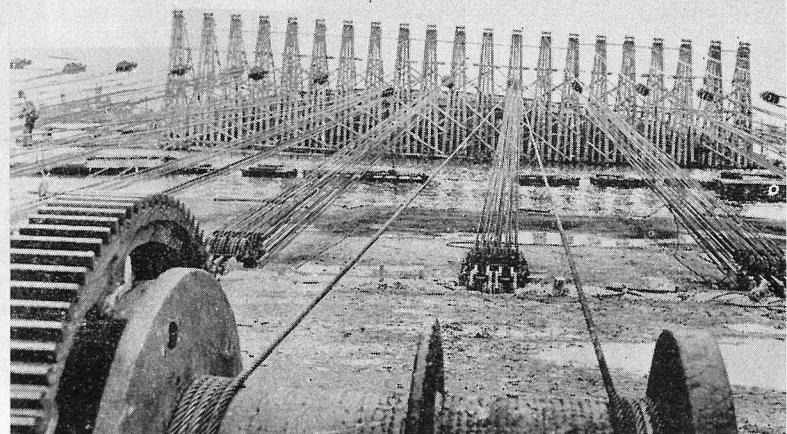
Fig. 8 LOWER RIGHT: View from Ford Island of the OKLAHOMA in 140° position. The three photographs in this group were all taken in March 1943. In this phase of salvage operations, righting was frequently interrupted to re-rig the tackles or because of rigging failures. Reasons for re-rigging included: Avoidance of too many layers of wire rope on winch drums; shifting tackle from "A" frames to the ship's structure. Failures occurred in the structure of "A" frame head fittings and in wire rope slings used to transmit the pull to various hull structures after "A" frames were removed.

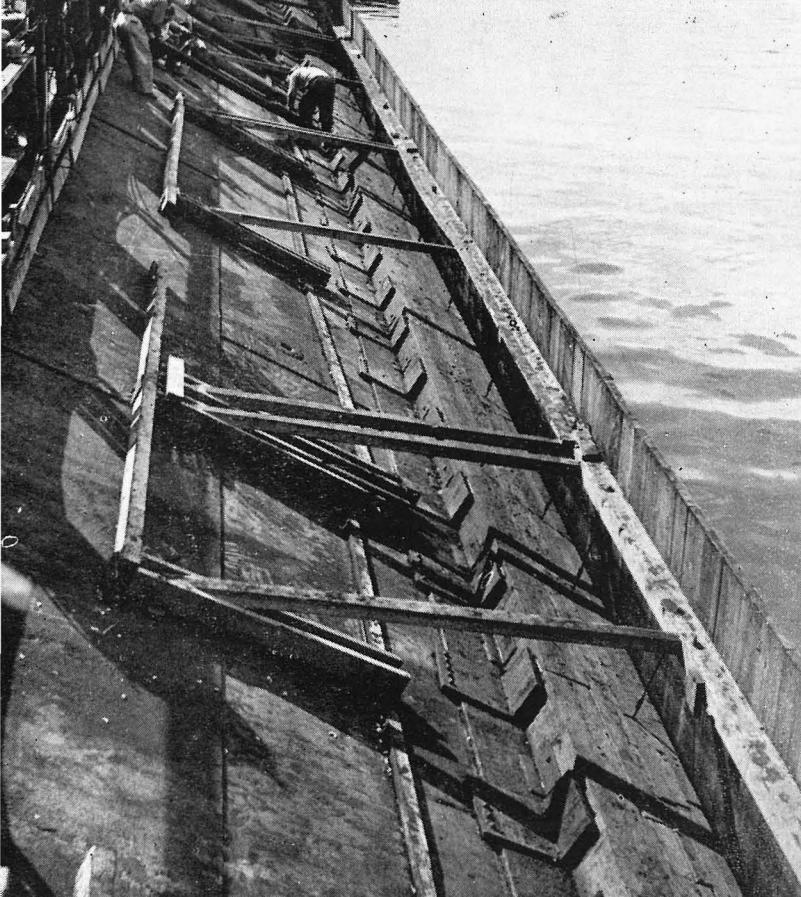
Fig. 9 Thrust brackets welded to the bottom along the centerline. Each bracket absorbed the force transmitted by individual compression members, of which there were four for each "A" frame. The cofferdam on the right holds water back during high tide.

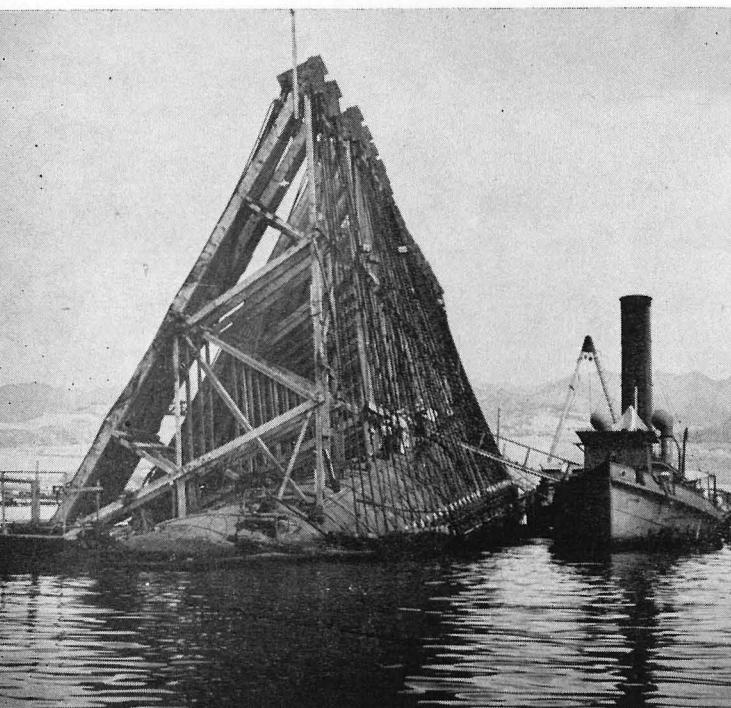
Fig. 10 "A" frames mounted on the ship's bottom. After the OKLAHOMA was rotated to a  $68^{\circ}$  position from the vertical, the frames were removed and the direct pull was assumed by the back stays. This photograph was taken in February 1943.

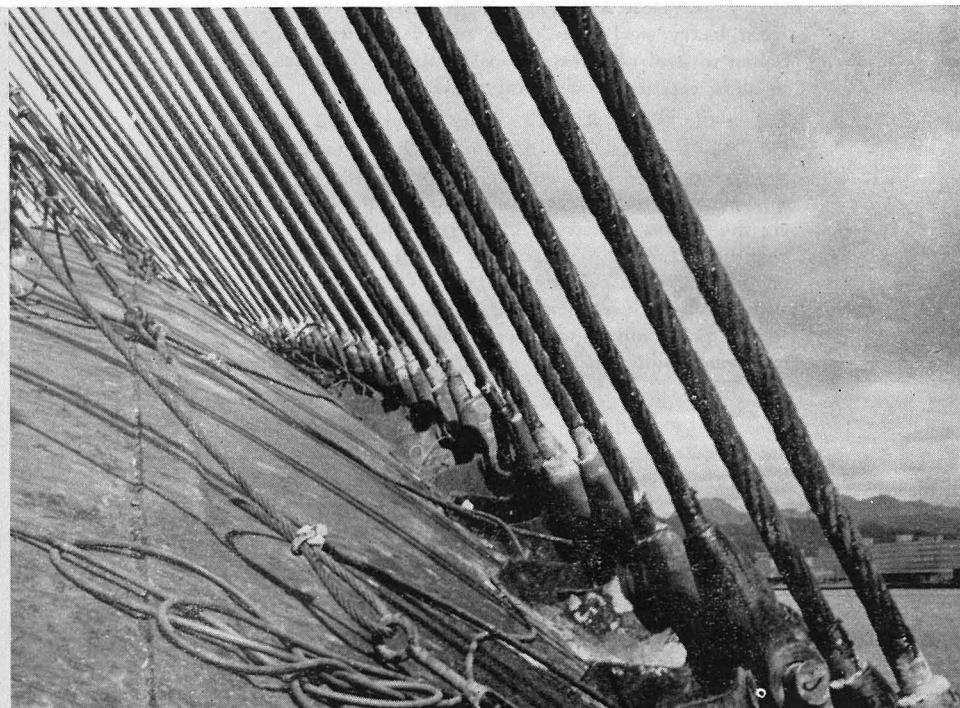
Fig. 11 Back stay detail. The back stay attachments consisted of pads welded to the starboard blister. The attachments were spaced at every frame of the hull to correspond to the individual compression members of each "A" frame. There were two back stays for each individual compression member. This photograph was taken a month after Fig. 10.

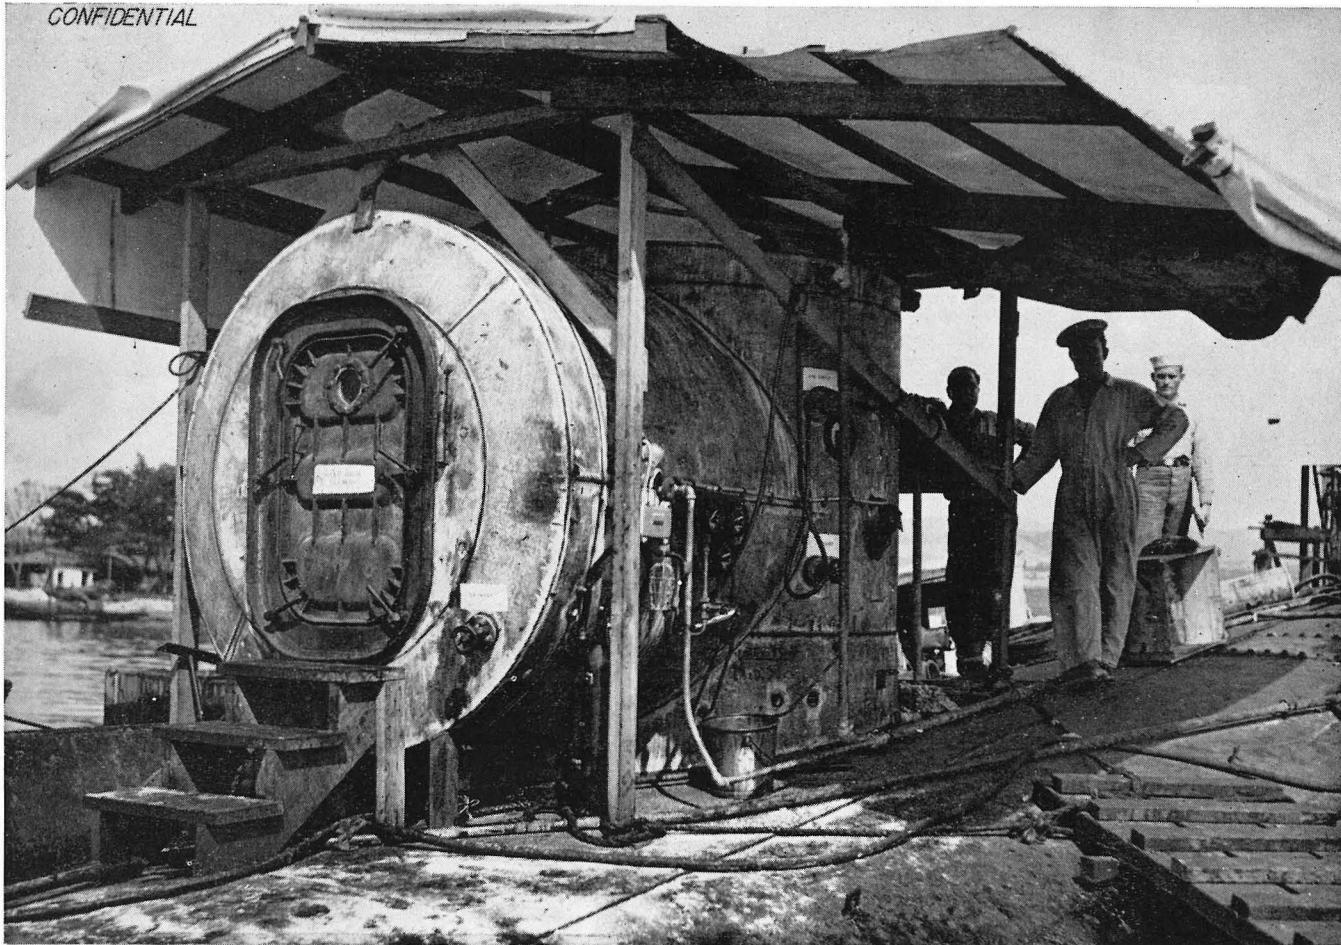
Fig. 12 Airlock for access to and from one section of the main air bubble. The bubble, designed to lighten the ship, was divided into seven sections which extended from stem to stern. It was effective from the bottom to the second deck, originally about 25 ft below the water level. Each air lock while being used was manned by a crew supervised by an officer diver.

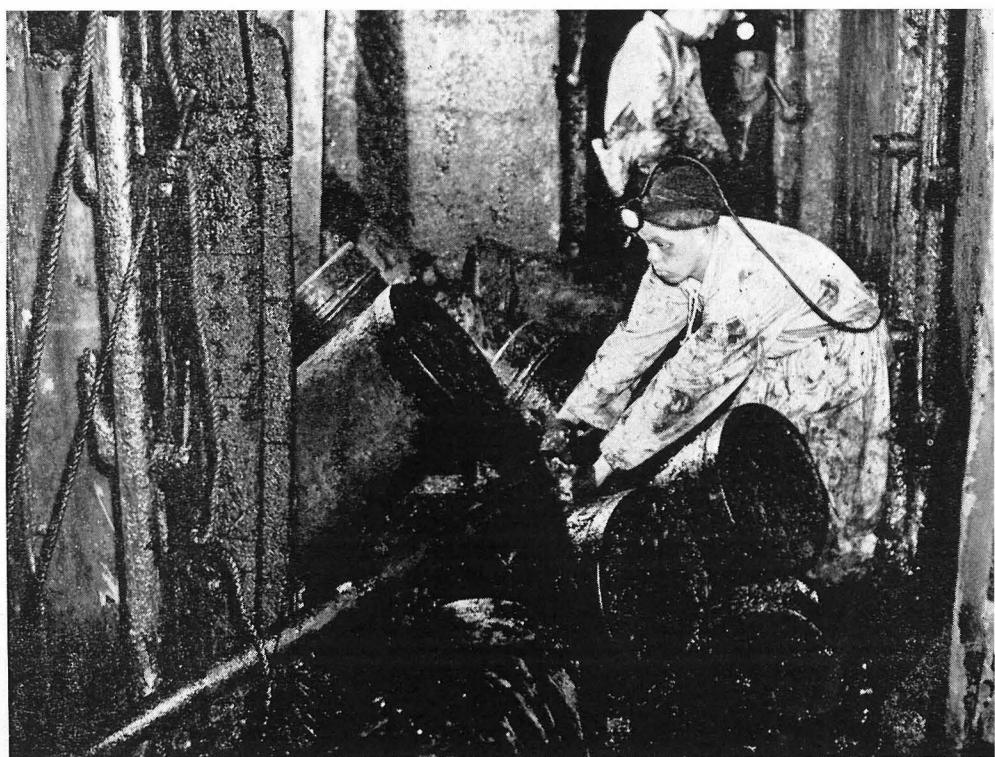
Fig. 17 Adjusting a discharge hose from a submersible pump in 14 in. magazine spaces during refloating operations. None of the 14 in. ammunition was removed because of the dangers and difficulties in handling.

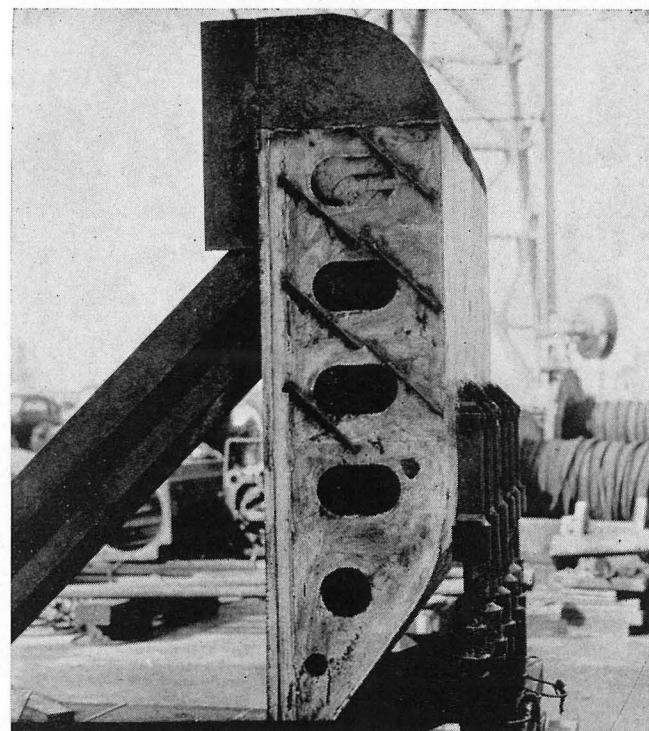
Fig. 18 One-fifth scale blister model. To determine the stresses to be induced in the starboard blister from the backstay connections, a model was designed to simulate the conditions. Hydraulic jacks were used to represent forces applied by the back stays. Premature buckling of the transverse members in the blister indicated diagonal stiffening would be required. This model has been reinforced by welding bars onto the transverse members and withstood the test. The OKLAHOMA starboard blister was similarly reinforced.

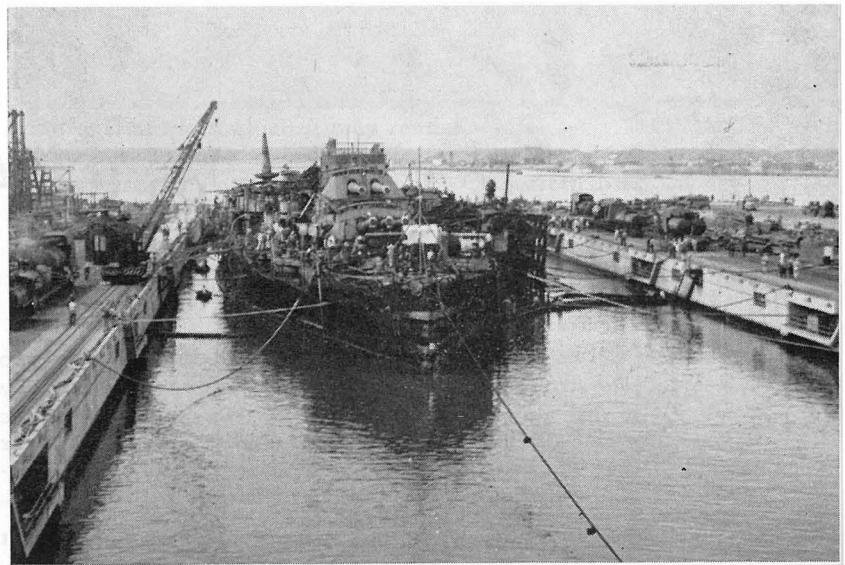
Fig. 20 UPPER: Forward section of the main five-section cofferdam patch. Preparatory to taking the measurements required for the design of the patches, considerable wreckage had to be removed from the port side by divers. Measurements were made by means of vertical and horizontal battens.

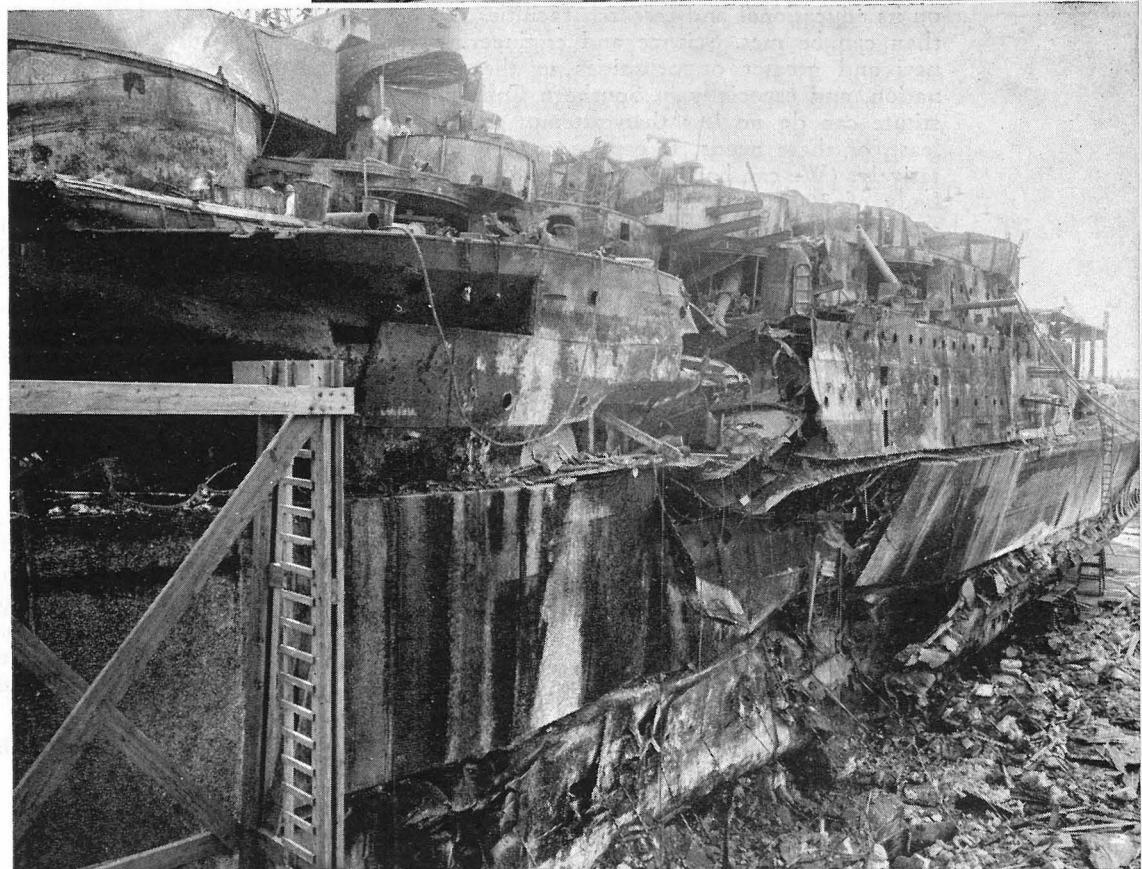
Fig. 24 Port side looking aft after removal of patches. These were removed by cutting the various supporting members. One of the important features in designing the patches was to insure against their premature collapse after the supporting forces of buoyancy and hydraulic pressure were removed when the ship was no longer water borne.
