Structural Behavior During the Loma Prieta Earthquake

by John F. Hall

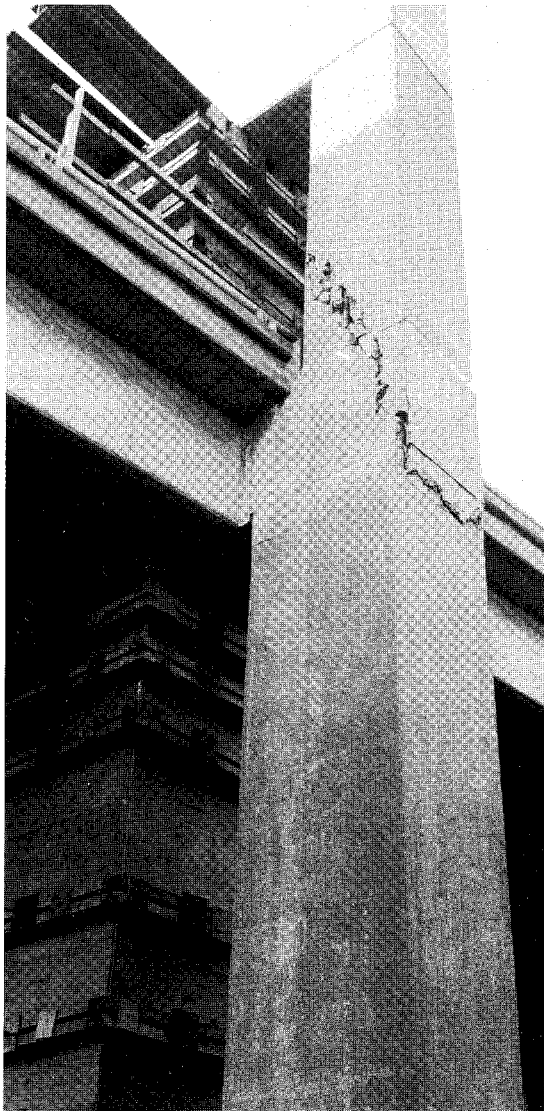
The double-deck Embarcadero Freeway, similar to the Cypress Street section of Interstate 880, came perilously close to collapse.

A multispan section of the Embarcadero Freeway, a double-deck bridge with similarities to the Cypress structure in Oakland, also came perilously close to collapsing (see photo on page 13). Indeed, the shear cracks in the columns suggest a collapse mechanism similar to that of the Cypress, resulting from a lack of ties in the columns. The Embarcadero remains closed to traffic and is temporarily shored up with timbers, awaiting a more permanent solution, such as retrofitting with the steel splints of the type tested at the Cypress test structure.

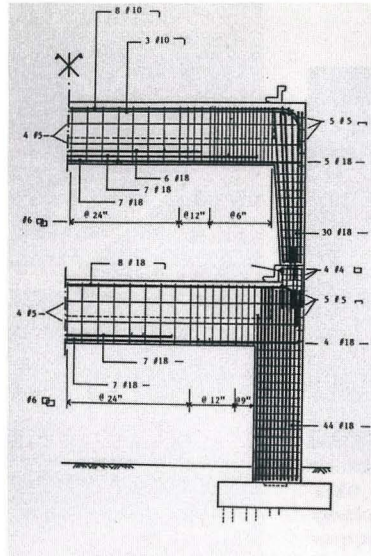
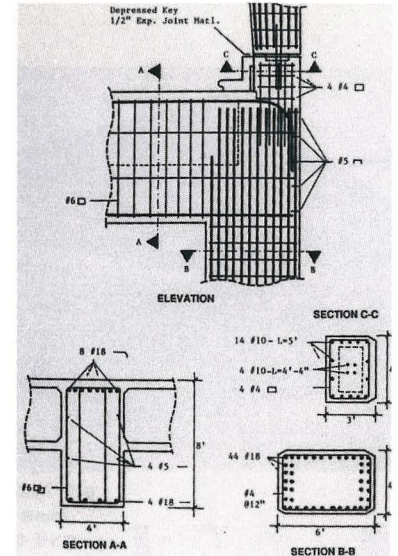
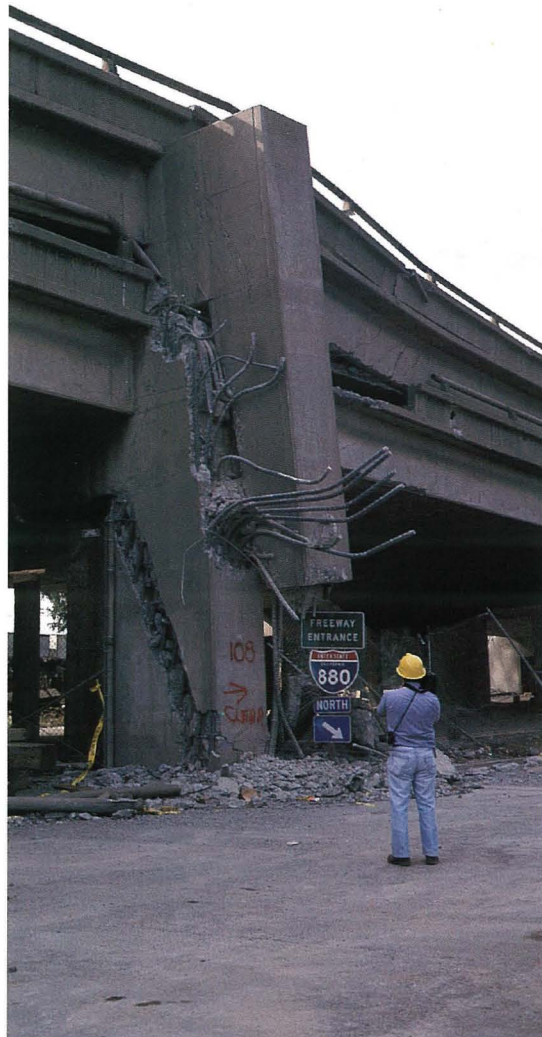
The design of the Cypress Street section of I-880 employed too few wrapping bars around the longitudinal steel reinforcement in the columns as revealed in the original plans (lower-level joint detail at far right; reinforcement layout bent at near right). This led to brittle shear failure at the base of the upper column (below).

The drawings above show the pattern of steel reinforcing bars in a typical bent (that is, a frame supporting the decks) of the Cypress structure. The design contains a flaw typical of most older reinforced-concrete structures: an inadequate number of the steel bars, called ties, that wrap around the longitudinal reinforcing bars in the columns. Too few ties make such columns prone to brittle shear failure during earthquakes, which is what happened to the Cypress. The area where the failure initiated is at the base of the upper column, and the failure plane is evident in the photo at left. The deck cabling did nothing to prevent this type of collapse and, in fact, may have helped propagate the failure from one span

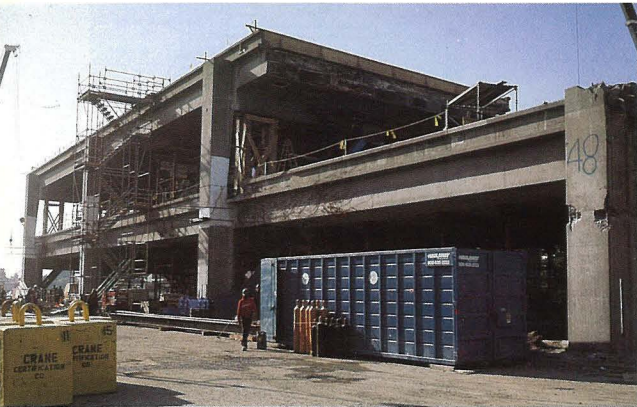
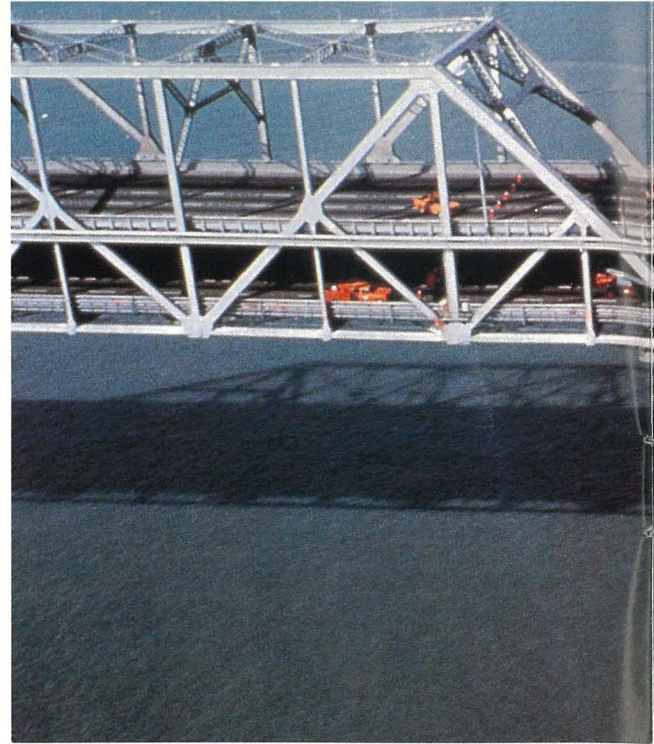
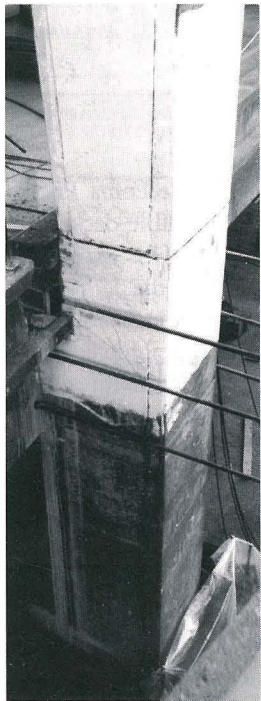
Load tests on a surviving section of the Cypress (top) produced the same type of critical shear cracks at the base of an upper column (bottom) that led to the failure of the structure during the earthquake.

After the earthquake the collapsed and still-standing portions of the Cypress structure were removed except for a two-span, double-deck section south of the part that collapsed. Interestingly, the portion of the Cypress that survived the earthquake was outside the zone of soft soil which underlay the part that collapsed. On the two-span section that was spared demolition, engineers from Caltrans and UC Berkeley recently conducted load tests using jacks placed between the upper deck and massive steel reaction frames, which were installed for this purpose. This type of loading forces the bridge back and forth in much the same manner as it would vibrate during an earthquake, although slower. The test structure was jacked far enough to produce the critical shear cracks at the base of the upper columns (left) confirming this to be the weak point in the design.

In a later stage of testing, three different methods for strengthening the test structure were tried out. The scheme considered to be the strongest consisted of steel I-sections fastened to the outside of the weakened columns to act as splints. After installation of the trial retrofits, the test structure was reloaded to determine the increase in strength obtained. Caltrans found all three schemes to be effective and plans to use

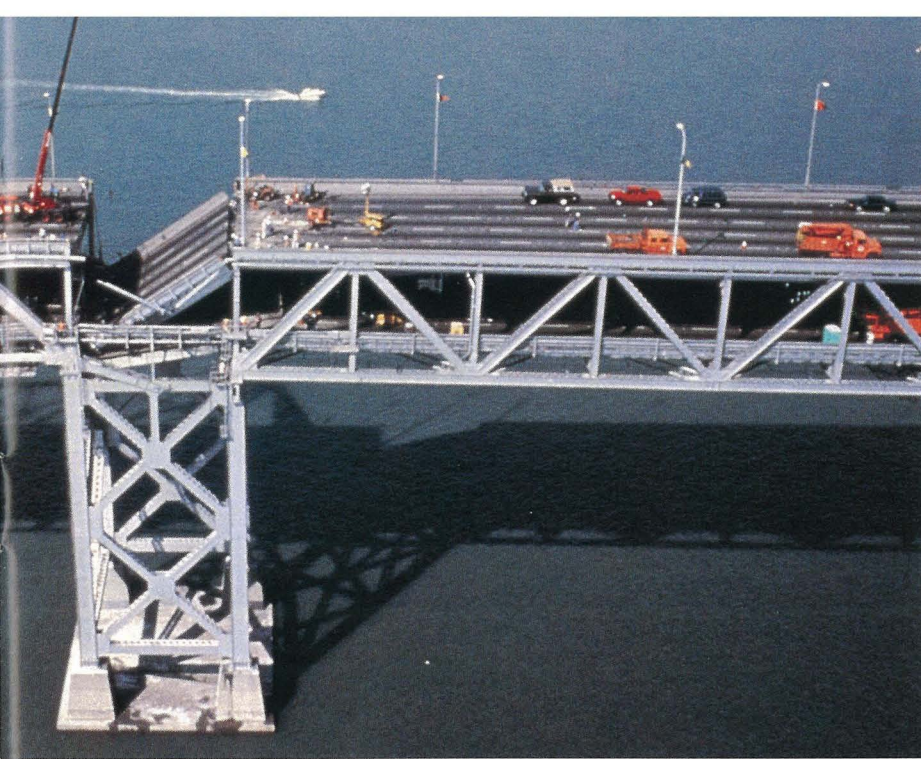
In the hours immediately following the earthquake, the most visible symbol of the damage was the collapsed upper and lower roadway decks in the trussed half of the Bay Bridge east of Yerba Buena Island (above). These decks had spanned 50 feet across a massive steel pier (number E9) connecting a 500-foot steel truss on the San Francisco side of the pier with a 300-foot one on the Oakland side. Bolted connections firmly attached these decks to the truss on the Oakland side of the pier, and a 5-inch-wide seat was employed at the end toward San Francisco to permit sliding. During the shaking the forces in the bridge truss on the Oakland side were sufficient to shear the bolts that connected the truss to the pier (top drawing, opposite), after which the truss moved 7 inches on the pier in the direction toward Oakland. This movement caused the decks over the pier, which were bolted to the moving truss at one end, to slide off their seat supports at the opposite end

50-foot upper- and lower-deck spans of the Bay Bridge collapsed across a pier when shaking broke loose one truss to which the decks were attached, resulting in a 7-inch movement toward the Oakland side, which pulled the decks off their seat supports on the San Francisco side.

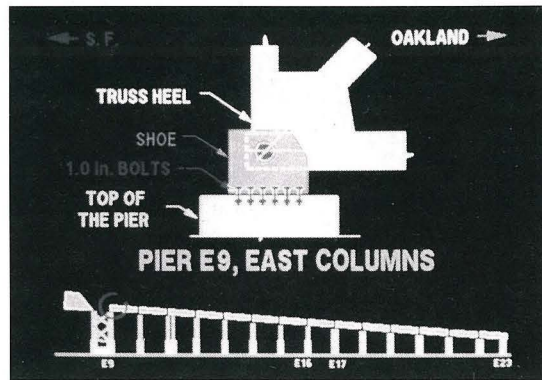
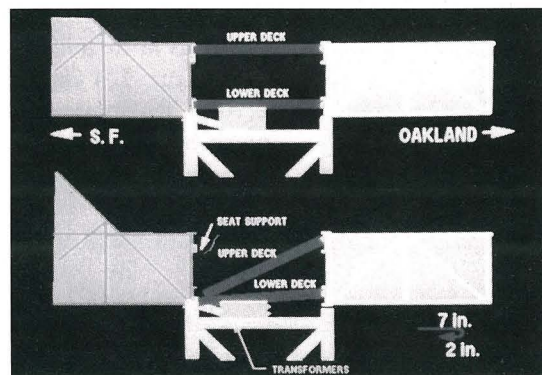
(bottom drawing). Unfortunately, no cabling retrofit work had been done over pier E9. Similar bolt shearing took place on several other piers closer to the Oakland end of the bridge and, amazingly, the last deck segment came to rest only $\frac{1}{2}$ inch from the edge of its seat without dropping.

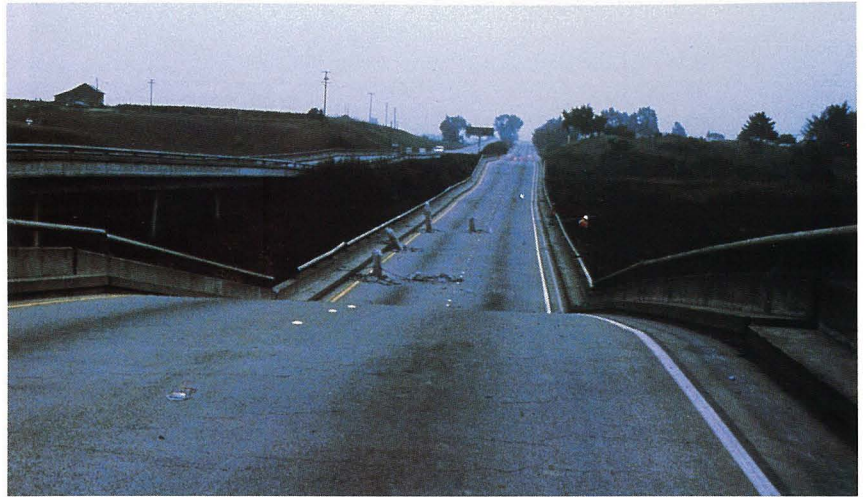
Damage was sustained by numerous major highway structures, and about half a dozen remain closed. One interesting collapse occurred to the parallel bridges across Struve Slough, a 1964 design, which involved 7 spans on one side and 10 spans on the other. Because of a very weak soil condition consisting of saturated peat, the bridge design employed a pile foundation. To support the bridge decks, the piles were extended upward above the ground and embedded into the undersides of cross beams to which the decks were connected. During the shaking the piles sheared off just below their connection

When the parallel bridges across Struve Slough collapsed in weak soil, some of the sheared-off supporting piles punctured the decks as they fell (right). Unreinforced masonry buildings close to the epicenter, such as the one below in the Pacific Garden Mall in Santa Cruz, did not fare well in the earthquake.

with the cross beams, and in a few cases held together enough to puncture cleanly through the deck as it fell, producing a rather eerie sight (above).

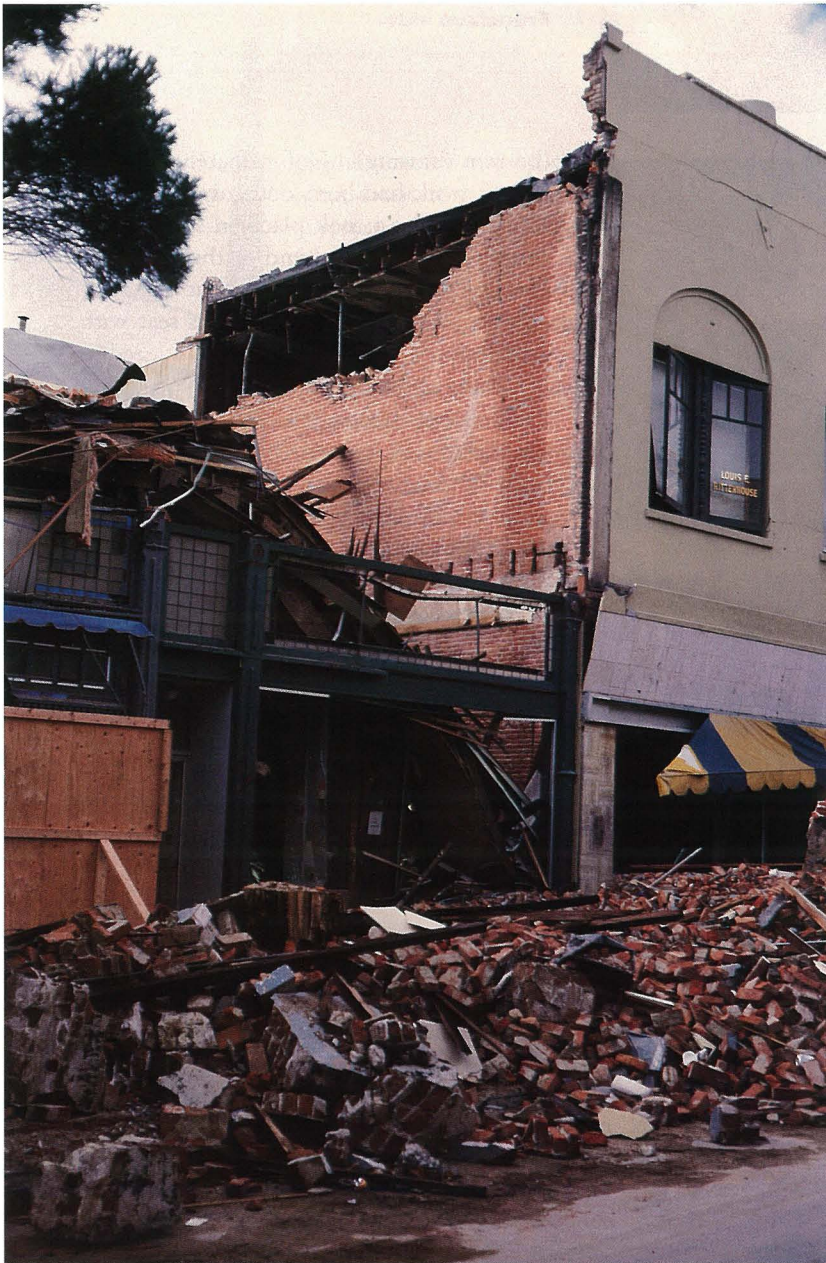
Unreinforced masonry (URM) buildings present a recognized serious hazard to the public during earthquakes. A few cities, such as Los Angeles, have had strengthening programs in effect for several years, and a 1986 California law requires all cities to inventory these old structures and develop mitigation plans by January 1, 1990. The wisdom of such a law was demonstrated by the damage and life-threatening partial collapses suffered by large numbers of URM buildings in the older downtown portions of Santa Cruz, Los Gatos, and Watsonville. The 2,100 URM buildings in San Francisco fared much better; only a few dozen experienced severe damage, with most of these on soft ground in the South of Market area. The majority of San Francisco's URM buildings, located on firm ground or rock, probably saw ground motions on the order of 5 to 10 percent of gravity, not high enough to cause serious damage. But San Francisco, which is still developing its mitigation plan under the 1986 law, should not find solace in the relatively good behavior of its URM buildings. An epicenter closer than the 95-km distance to the Loma Prieta epicenter would have caused much more damage to these brittle structures.

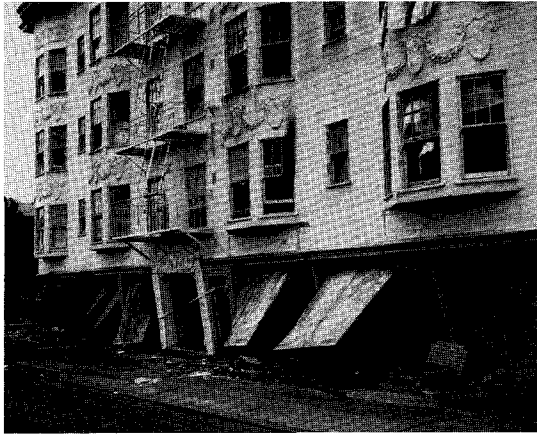
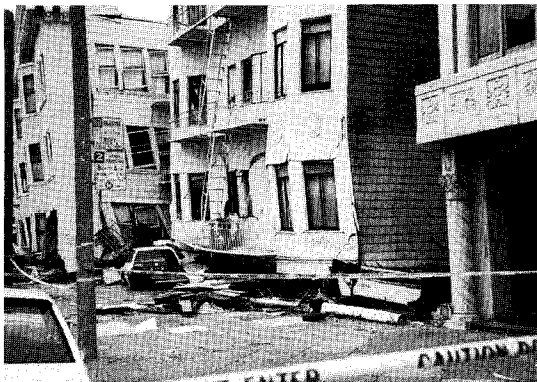
Damage in San Francisco's Marina district was widespread because of building style, soil conditions, and fire.

three- to five-story, wood-frame residential buildings dating from the 1920s and contained open first-story parking areas with little bracing (top left). Several of these collapsed in their first story (middle left). The soil in the zone of damage was a loose fill placed in 1915 for the Panama-Pacific Exposition. Evidence from other locations where records of ground motions were obtained indicates that such material amplifies the ground shaking considerably, and this amplification increases the likelihood of damage. The fill material is also prone to liquefaction, and evidence of liquefaction abounded in the Marina. Liquefaction is a type of ground failure and contributed to the structural damage by causing differential settlement of the buildings. Structures similar to those damaged, but located just a few blocks away on firmer ground, sustained little damage.

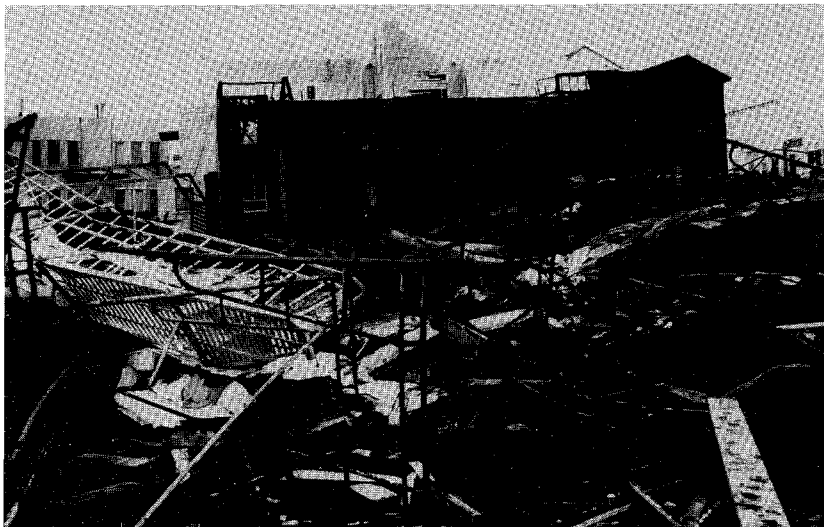
A fire in the Marina district, an area densely populated with wood-frame structures, proved to be particularly troublesome (aftermath shown in bottom photo). Water was initially delivered to the site from a hydrant in front of the building where the fire ignited (until the building collapsed on the hydrant); then from another nearby hydrant (until breaks in the municipal water system and in a high-pressure auxiliary water system dropped the water pressure); then from the lagoon at the Palace of Fine Arts four blocks away (until other buildings collapsed on the fire hose); and finally from Marina Lagoon via the fireboat *Phoenix*. This effort took about an hour, by which time the fire had spread to other buildings and was shooting flames 75 feet into the air. Control of this fire and more than 20 other smaller ones taxed San Francisco's fire department to its full capacity. Just a few more fires or water-pressure problems might have overwhelmed the local fire-fighting capability right after the earthquake and greatly increased the role of fire in the overall damage. □
