# RESIDENTIAL ILLS

## in the Heartbreak Hills of Southern California

by *Richard H. Jahns*

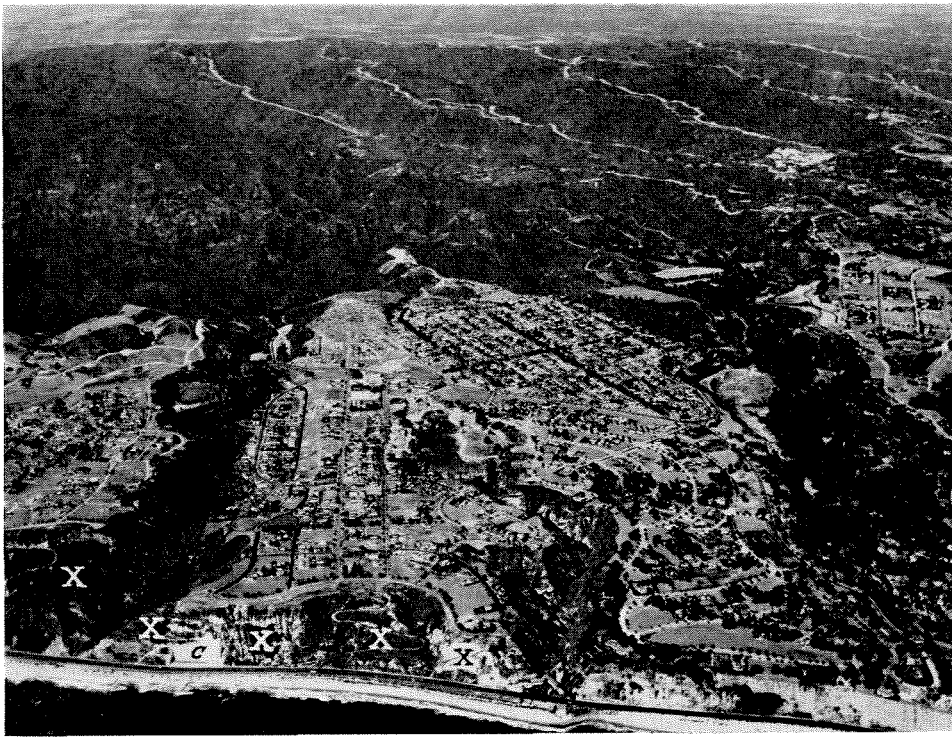
*Settlement of coastal terraces in the Pacific Palisades area, 1946. Large landslide masses (X) face the ocean, and a steep-walled cut (C) exposes old slide debris.*

The Pacific Palisades area recently has become well known for its large slides, although geological evidence indicates that sliding has occurred again and again in this locality for thousands of years. As shown above, human settlement has extended over a broad,

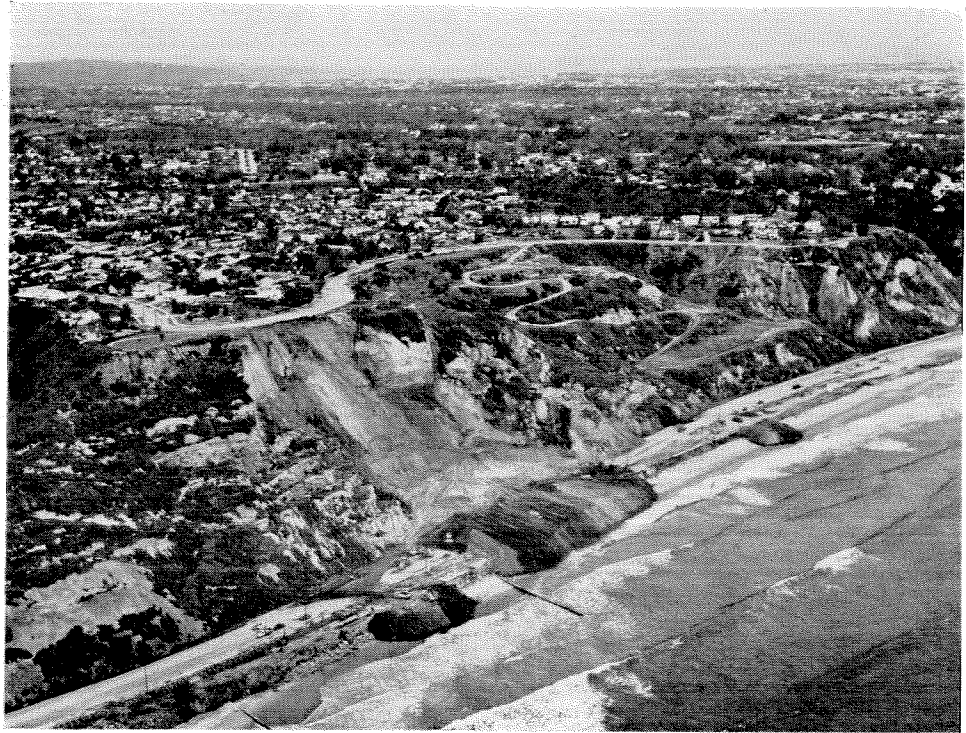
*Landslide mass covering U.S. Highway 101 in the Pacific Palisades area, March 1958. Note that somewhat earlier sliding has concealed the cut (C) shown on the page opposite.*

Sliding has occurred at points along the ocean front and along the sides of tributary canyons whenever the structure of the bedrock is unfavorably oriented. The crescentic expression of one large slide can be seen on page 16; this mass is traversed by the loops of road extending from the edge of the cliff downward to Highway 101. Mass movements have occurred repeatedly during recent years, the latest episode following heavy winter rains in 1958. The position of this slide and its effect in trimming back the edge of the sea cliff are shown above. To the left of this mass are several other, slightly older slides.

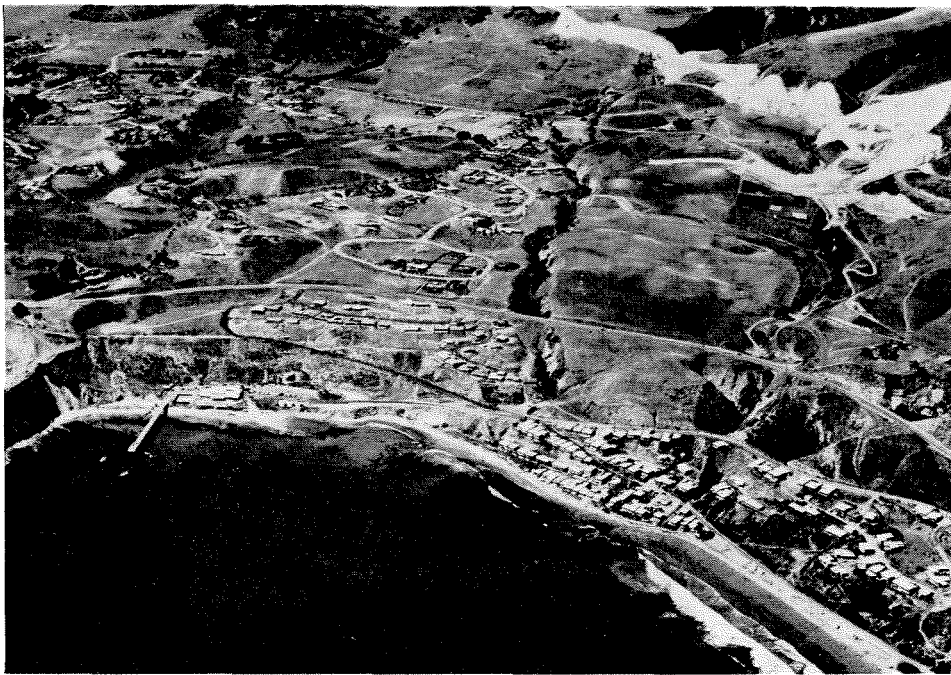
The Portuguese Bend area in the Palos Verdes Hills, looking north-northwest, 1955. Most of the homes in the central foreground and middle distance are now abandoned.

The entire Portuguese Bend settlement is rapidly becoming a ghost community. A supplemental tragedy is the effect of the landsliding upon the newly developed tract immediately to the east, which appears within the area of curving streets in the middle distance above. Although these new homes rest upon stable ground, their proximity to the slide has had unfortunate effects on current estimates of their value by the general public.

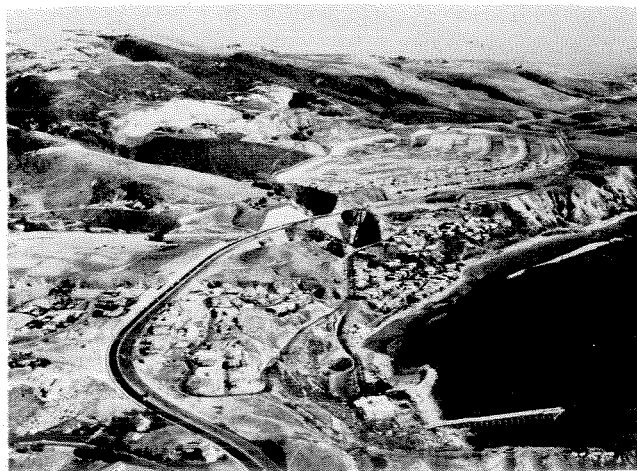
*Coastwise view of the Portuguese Bend area, December 1956, showing the slide mass in left foreground. The snout of the mass emerges on the ocean bottom along the surf zone between the pier in the foreground and the white breakers in the right distance. Buckling of the pier can be seen near its shoreward end.*

The principal features of the slide mass are shown on the page opposite. Its curving upper margin is characterized by a series of fresh scarps and "pull-away" trenches. Preserved along the walls of these trenches are grooves and striations that indicate the downward movement of the migrating ground (see below). The lateral margins of the active slide mass are marked by zones of profound shearing. The eastern part of the mass, which has moved farther than the other parts, is separated from the remainder of the slide by a shear zone in the vicinity of Portuguese Canyon (see p. 18). Maximum horizontal movement has amounted to nearly 30 feet. The entire mass is thoroughly fissured and fractured, like the ice in a glacier that is flowing over a very uneven bedrock surface, and it is marked by many structural complications. The snout of the slide appears along the sea coast, in most places as a low ridge of crushed and broken material in the zone of wave action. It is being thrust upward along stable bedrock that forms the sea floor (shown at the bottom of page 18) where it is being attacked by the marine waters.
