SURVEYOR TO THE MOON

A long, tense wait at Caltech's Jet Propulsion Laboratory—then jubilation as Surveyor I makes a perfect soft landing on the moon.

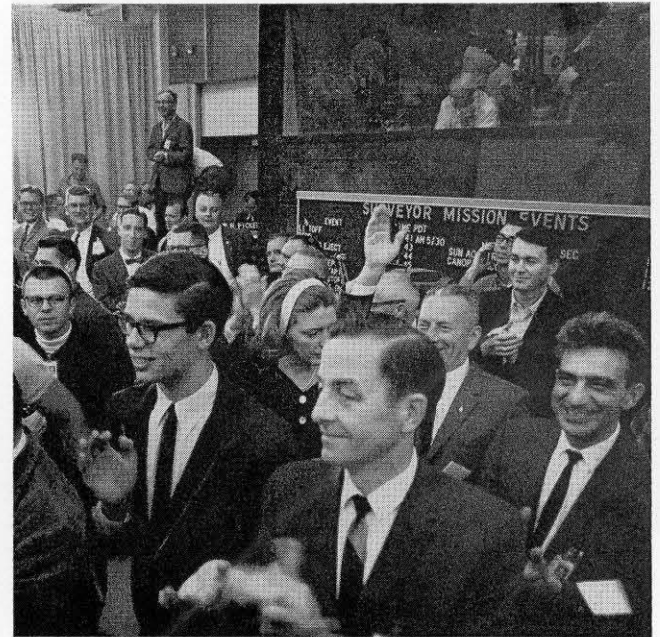
Touchdown! Surveyor's first picture from the moon, received at 11:52 p.m. PDT June 1, was immediately flashed on home television screens. It shows one of the spacecraft's landing legs, its foot pad, an antenna boom, and the top of a helium container.

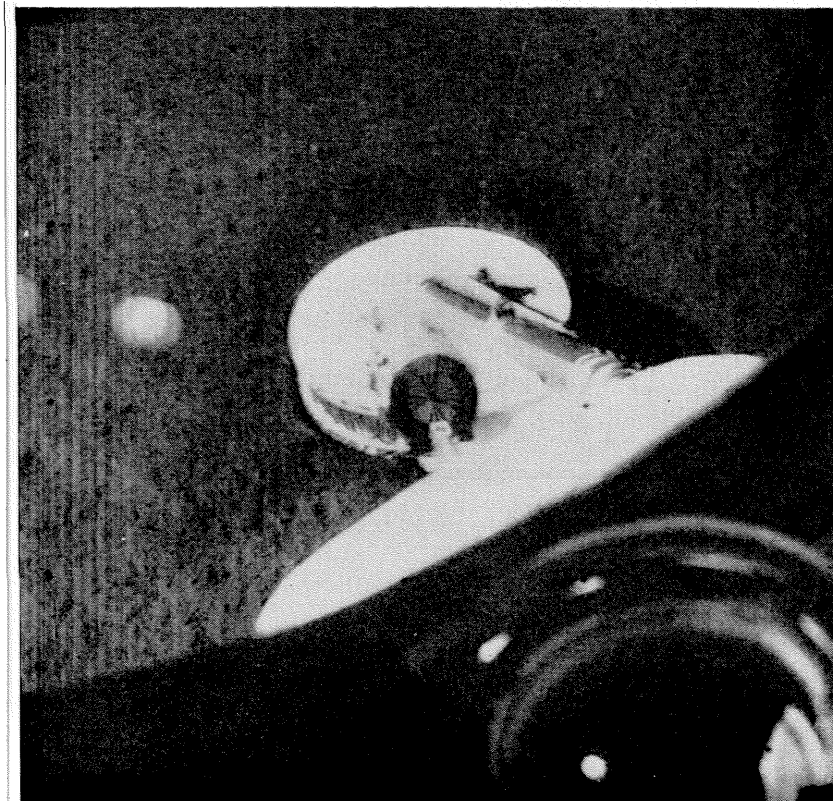
A landing foot resting on the surface shows that the landing site—on the floor of the crater Flamsteed in the Ocean of Storms—is strong enough to support the weight of an Apollo landing craft.

Surveyor's feet sank only a little way into the material on the moon's surface, indicating that if there is a dust layer, it is either relatively hard or fairly shallow.

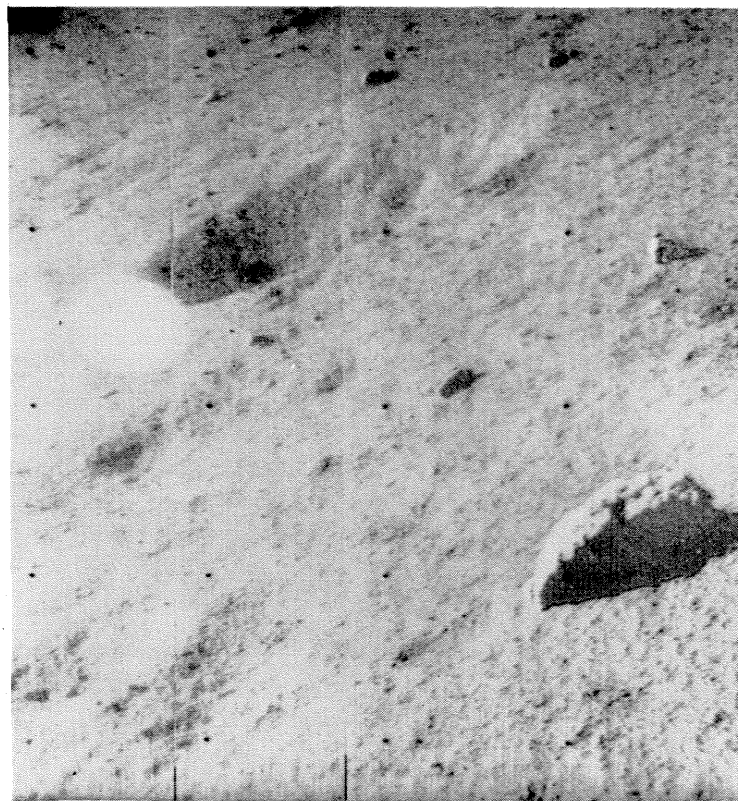
This view shows a large rock, several smaller rocks, and a crater about a yard deep in the surface layer. The grid of black dots is part of the television tube; the bright spots are reflections of the sun.

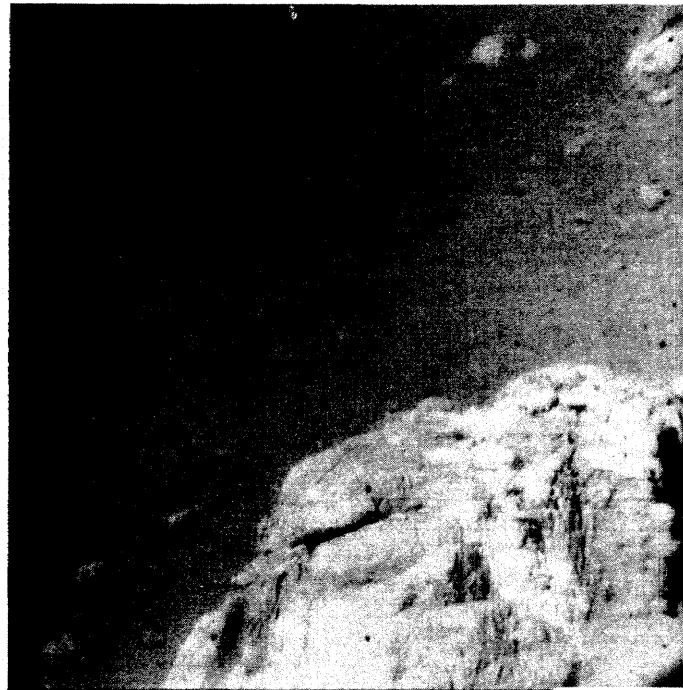
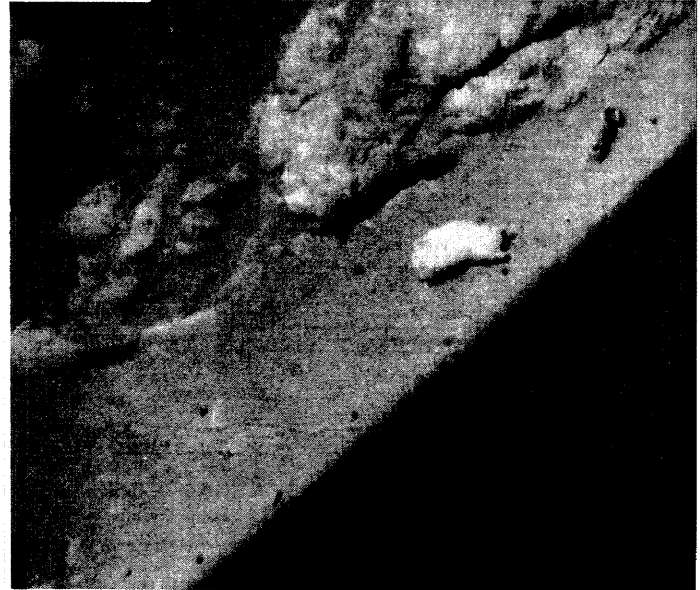
The surface of this rock (about 18 inches long) is eroded or abraded, probably by bombardment of fine particles. The rock also shows evidence, in its slaty cleavage, of having undergone plastic flow of the type produced by conditions of strong shock.

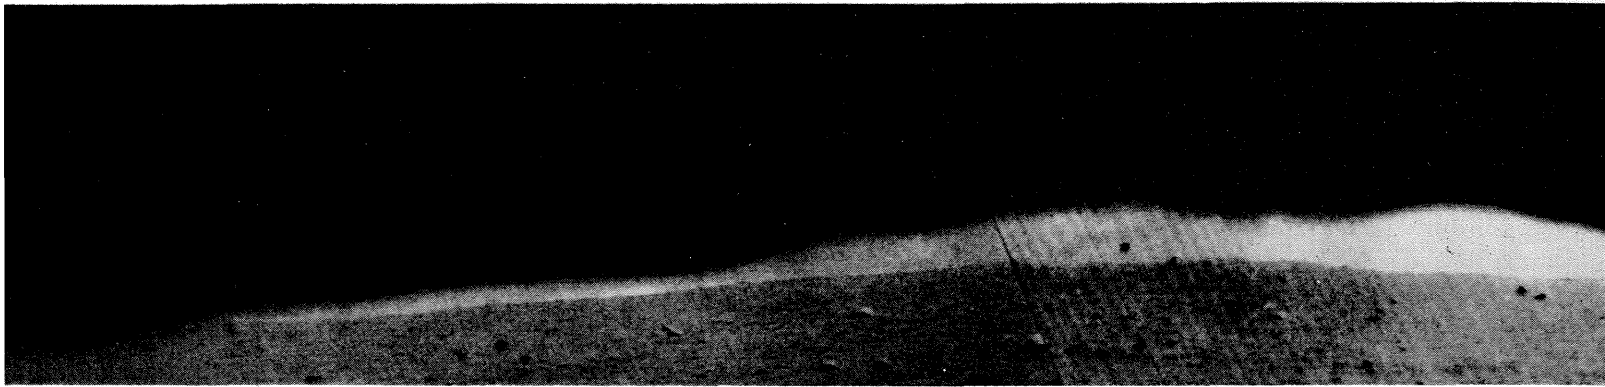
Only the top of a small, ghostly mountain range about 12 miles from the spacecraft shows above the lunar horizon, which is probably less than a mile away. The

portion that can be seen is a little less than 8 miles long and rises 500 feet above the near horizon. It is part of the nearly buried crater in which Surveyor landed.

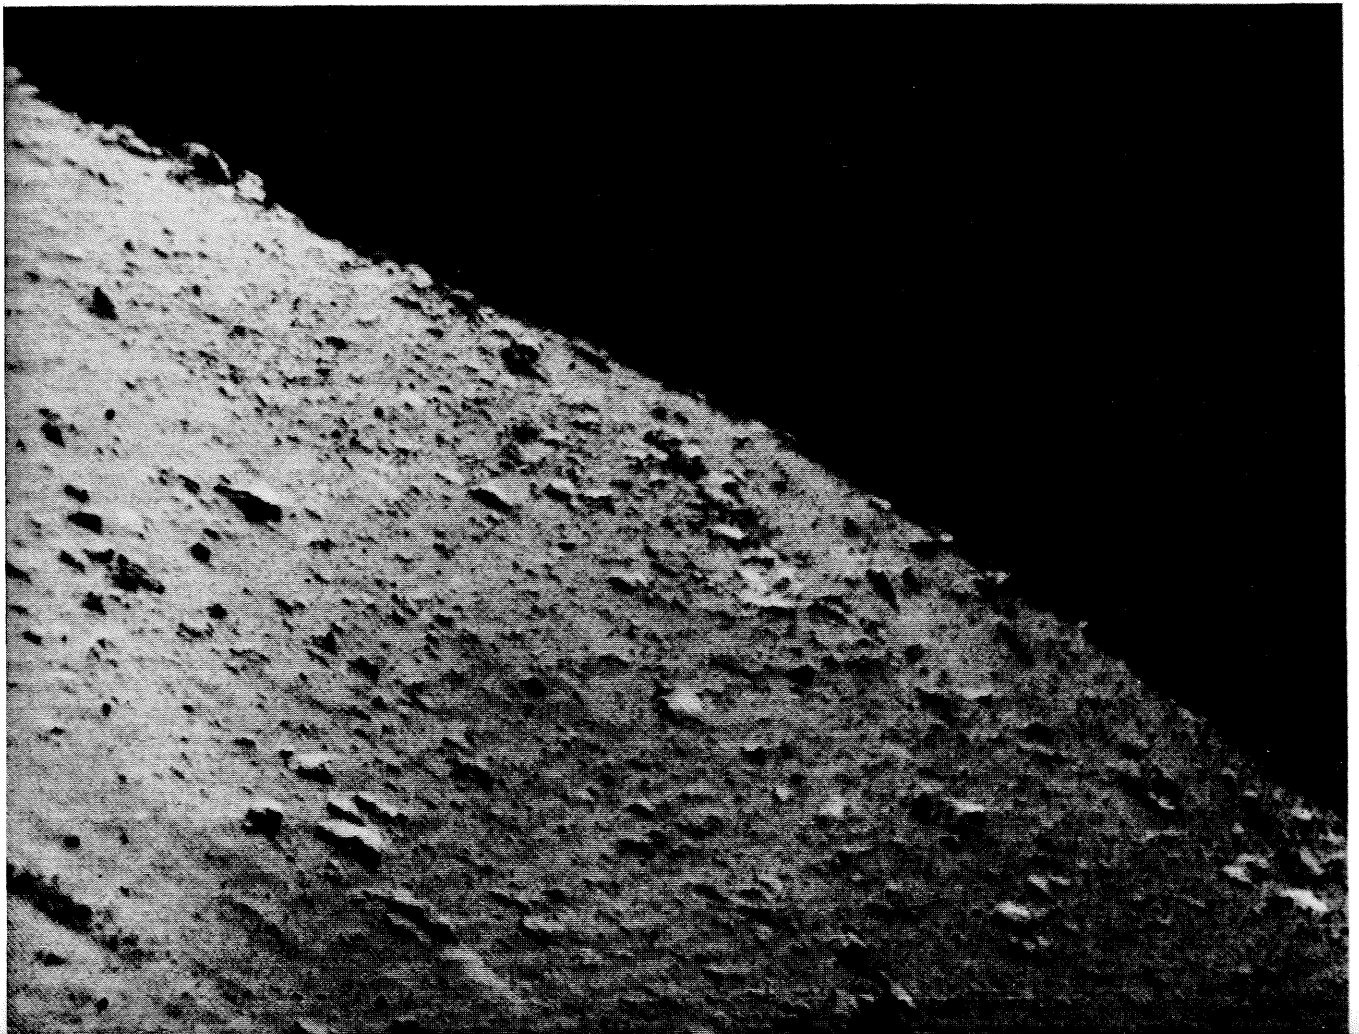
The boulders strewn over this field probably came from the crater whose outer rim can be seen along the horizon. Those boulders in the upper left may be one or two

yards across. Had the spacecraft hit one of them during landing, it could have tipped or even broken apart. The distance to the horizon is several hundred yards.

Although the actual ground surface is quite flat at the landing site, the numerous large boulders nearby are large enough to have spoiled the soft-landing if the spacecraft had come down a few hundreds yards away.
