# Engineering Features of the Recent Mexican Earthquake

by James L. Beck and John F. Hall

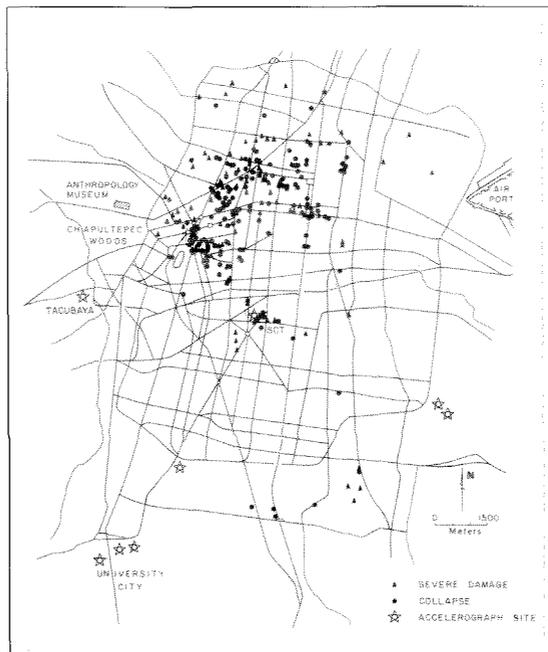
Figure 2 (left): Distribution of severe structural damage and sites where records of the strong ground shaking were obtained. Only some of the major streets of Mexico City are drawn. Damage is confined to areas on the old lake bed.

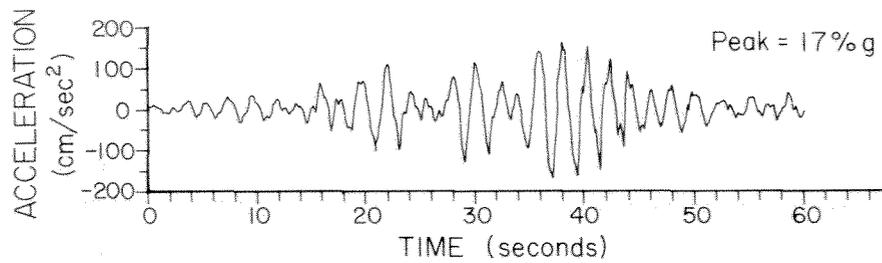
But no one anticipated the amount of amplification of the ground motion in the old lake sediments. A strong-motion record obtained at the SCT site (Ministry of Communications and Transportation) on the lake bed shows a ground acceleration history of long duration, which peaked at 17 percent of gravity and whose frequency content is dominated by a component with a period of two seconds (figure 3). In contrast, the ground motions recorded on firm ground in Mexico City show a broader frequency content and exhibit peak accelerations in the range of 3 to 4 percent of gravity, a factor of 4 to 5 less

Figure 3: Ground acceleration in the east-west direction at the SCT site on the old lake bed.

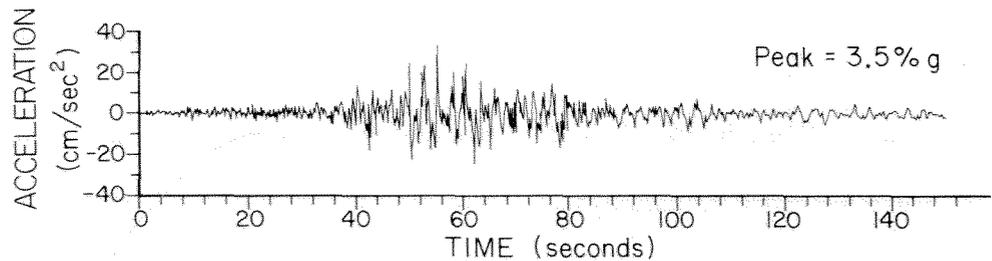
than at the SCT site. An example of a firm ground record is shown in figure 4, which is from an accelerograph at the Seismological Observatory at Tacubaya on the western side of the city. The SCT record was published two days after the earthquake by Professor Jorge Prince and his colleagues at UNAM, and it plays an important role in establishing quantitatively how strong the ground shaking was on the lake bed. Unfortunately, this record was the only one obtained within the area of damage in the city, but ground motions of a similar general character probably occurred throughout the area.

Figure 4: Ground acceleration in the east-west direction at the Seismological Observatory, Tacubaya, which is on firm ground. Note that the time scale is half of that in figure 3.

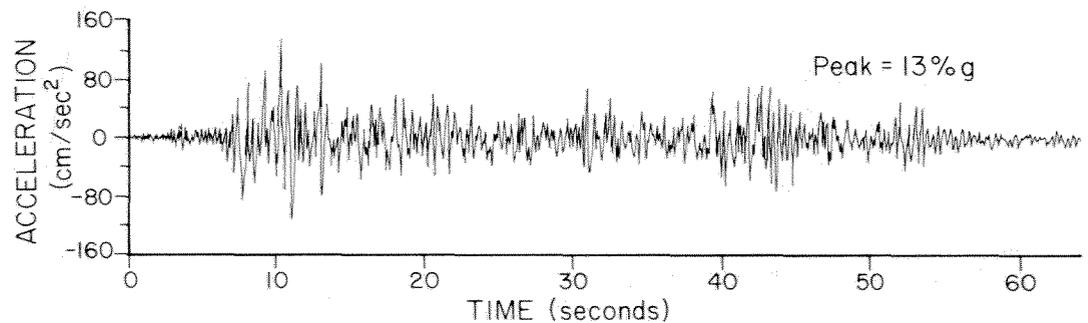
Figure 5: Ground acceleration in the north-south direction at La Villita near the center of the rupture zone on the Pacific coast.

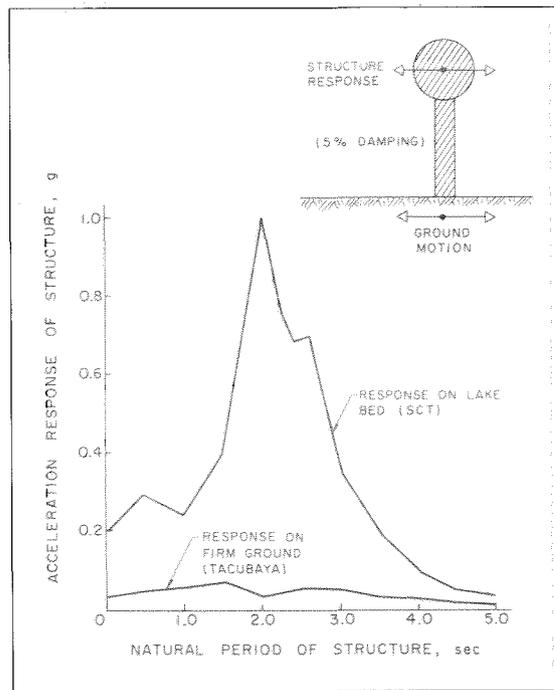
Figure 6: The engineering significance of earthquake ground motion is revealed by the response spectrum, shown here for the Tacubaya and SCT ground motions. A response spectrum shows the maximum response to the earthquake reached by an elastic mass-spring oscillator (i.e. an idealized building) as a function of the vibrational period of the oscillator. The SCT ground motion excites a much larger response than does the Tacubaya motion, especially when the period of the oscillator is near the predominant two-second period of the SCT ground motion, because this is when resonance occurs. Since the fundamental period of vibration of an  $N$ -story building is given by  $N/10$  seconds, buildings in the 15-to-30-story range located on the soft clay layer should be most vulnerable.

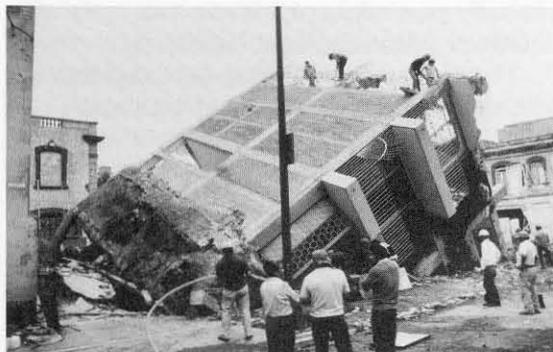
*Below: Even in the severely damaged areas of Mexico City, many buildings survived undamaged, some without even a single broken pane of glass. Why did some buildings fare well while others suffered? Were building collapses due to gaps in engineering knowledge or to sloppy design or construction? Is the building code adequate? These questions remain partially unanswered. Unfortunately, a lack of detailed documentation of the damage following the earthquake, the subsequent demolition and removal of many buildings without inspection or material testing, and the legal difficulty of gaining access to the structural plans of the buildings may prevent these questions from being completely answered.*
