# SALVAGE OF THE OKLAHOMA

## at Pearl Harbor

By LEE P. MORRIS

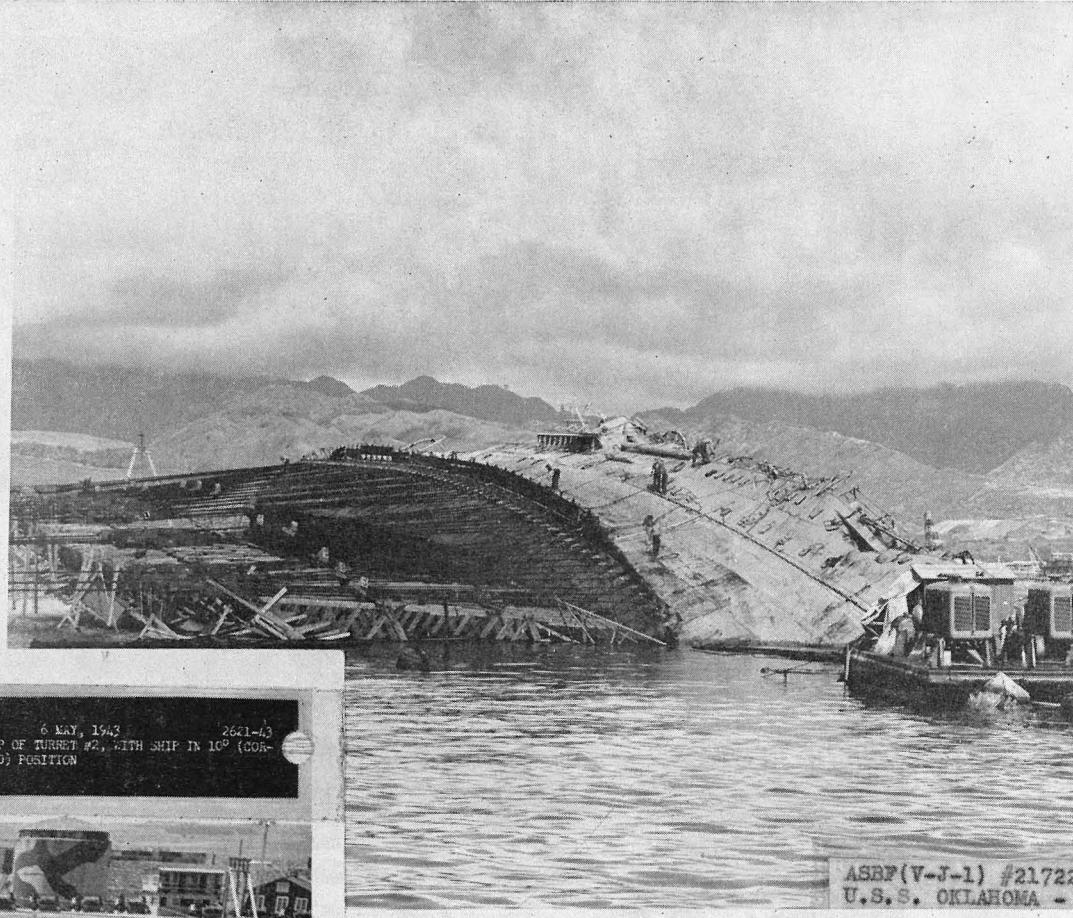
ASRF(V-J-1) #21722  
U.S.S. OKLAHOMA

USS OKLAHOMA - SALVAGE  
6 MAY, 1943  
VIEW TOWARD FORD ISLAND FROM TOP OF TURRET #2, WITH SHIP IN 10° (CORRECTED) POSITION  
2681-43

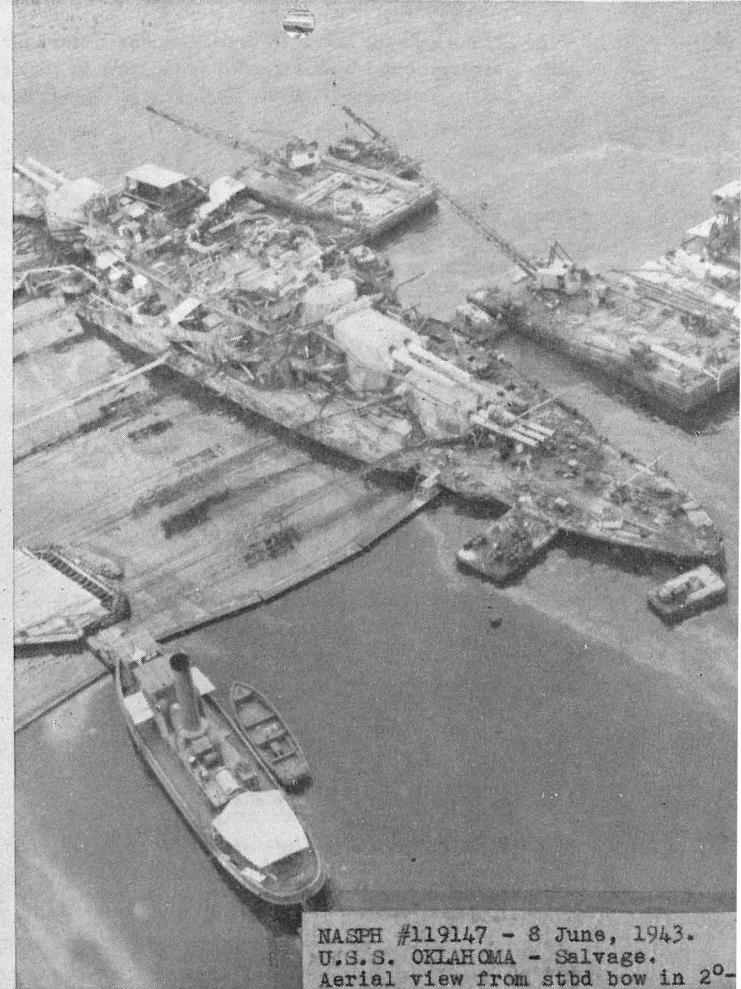
NASPH #119147 - 8 June, 1943.  
U.S.S. OKLAHOMA - Salvage.  
Aerial view from stbd bow in 20°.
