Structural Behavior During the Loma Prieta Earthquake

by John F. Hall

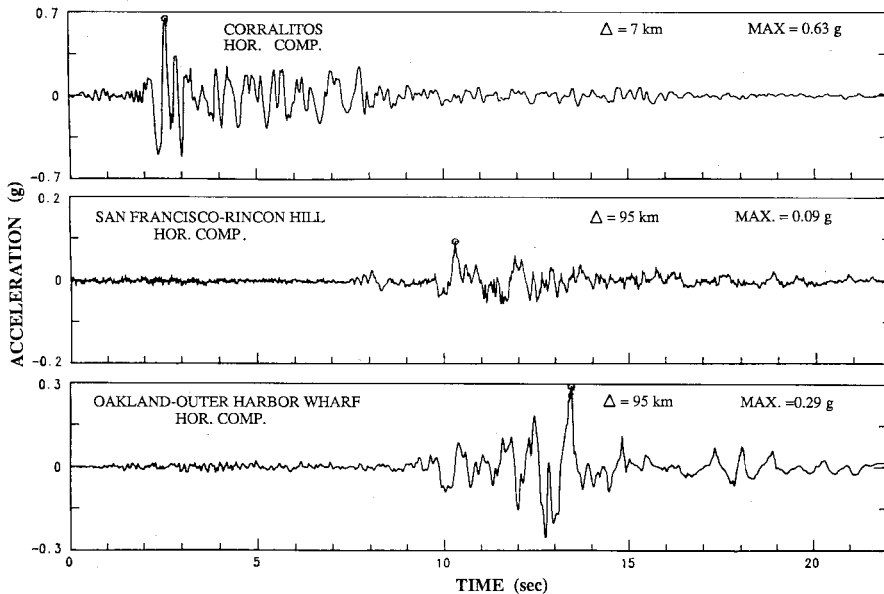
The top accelerogram shows ground motion in terms of acceleration over time at a site 7 kilometers from the epicenter. Comparison of accelerograms from two locations far from the epicenter—on rock in San Francisco (middle) and on mud overlying sand in Oakland (bottom)—illustrates the amplification of ground motion on soft soil.

A wealth of data was obtained on the nature of the strong shaking generated by the earthquake. These data are records of the motion in terms of acceleration versus time (accelerograms) captured by special vibration recording instruments (accelerographs). Dozens of accelerographs installed over the years by CDMG and USGS triggered during the earthquake. Shown at left are three accelerograms from CDMG; all show a single horizontal component of motion at a particular site on the ground. The Corralitos station was the closest to the epicenter ($\Delta = 7$ km, where $\Delta =$ epicentral distance), and there the ground acceleration exceeded 60 percent of gravity with a strong shaking duration of about six seconds. The other two accelerograms were both recorded 95 km from the epicenter, one on rock (in San Francisco on Rincon Hill) with a 0.09 g peak acceleration, and the other on 10 feet of fill and bay mud overlying sand (at Oakland's Outer Harbor Wharf) with a 0.29 g peak acceleration. These two records illustrate the amplification of ground motion that can occur on soft soil. Such amplification probably played an important role in much of the damage that occurred during the earthquake, such as in the Marina District and the South of Market area in San Francisco and at the Cypress Street section of the Nimitz Freeway (Interstate 880) in Oakland. The Oakland Outer Harbor Wharf station was only 2½ km from the collapsed portion of the Cypress, and the motions at these two locations are thought to have been similar.
